CORROSION FIELD TEST OF STEELS COMMONLY USED IN WELL CASING AND SCREEN

City of Fountain Valley

July 29, 1999

WELL NO. 7

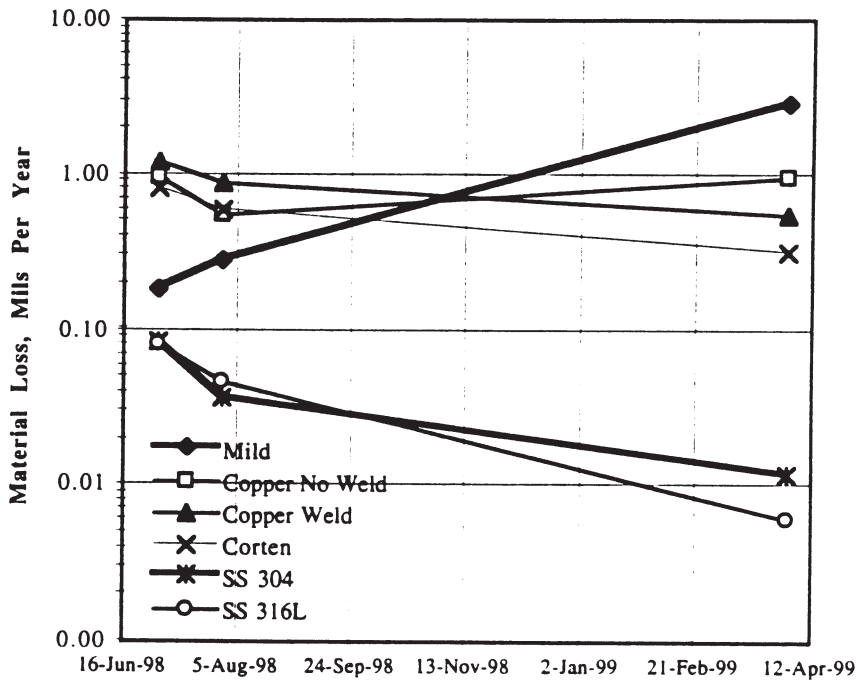
**Results of Steel Coupon Testing
City of Fountain Valley - Well No. 7**

Due to its greatest resistance to corrosion effects such as pitting and material loss, stainless steel 316L is recommended for use in future well projects in the vicinity of Well No. 7. Both stainless steel coupons, especially Type 316L, had significantly lower material loss than the others. The following figure shows corrosion rates and summarizes the results of this study:

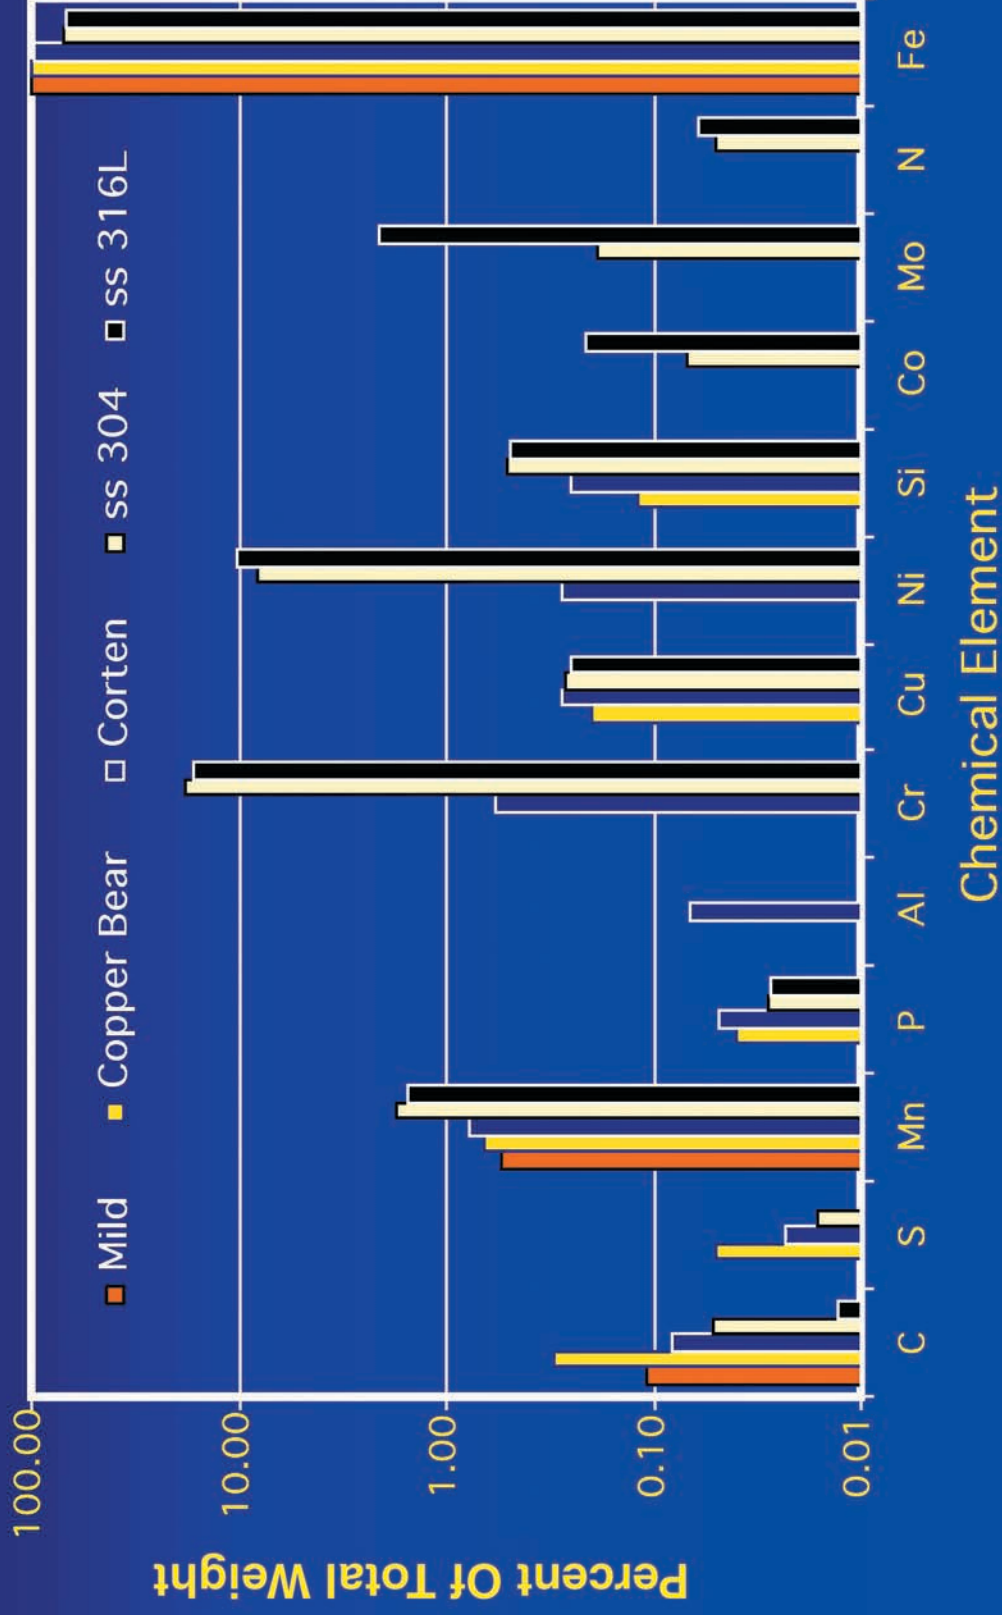
Chemical Composition Of Casing And Screen Materials

The metal coupons were manufactured from five different steels commonly used in well casings and screens: Mild, Copper Bearing, Corrosion Resistant High Strength Low Alloy (Corten), Type 304 Stainless (SS 304), and Type 316L Stainless (SS 316L). The chemical compositions of these five steels are depicted in Figure 1 and the following table:

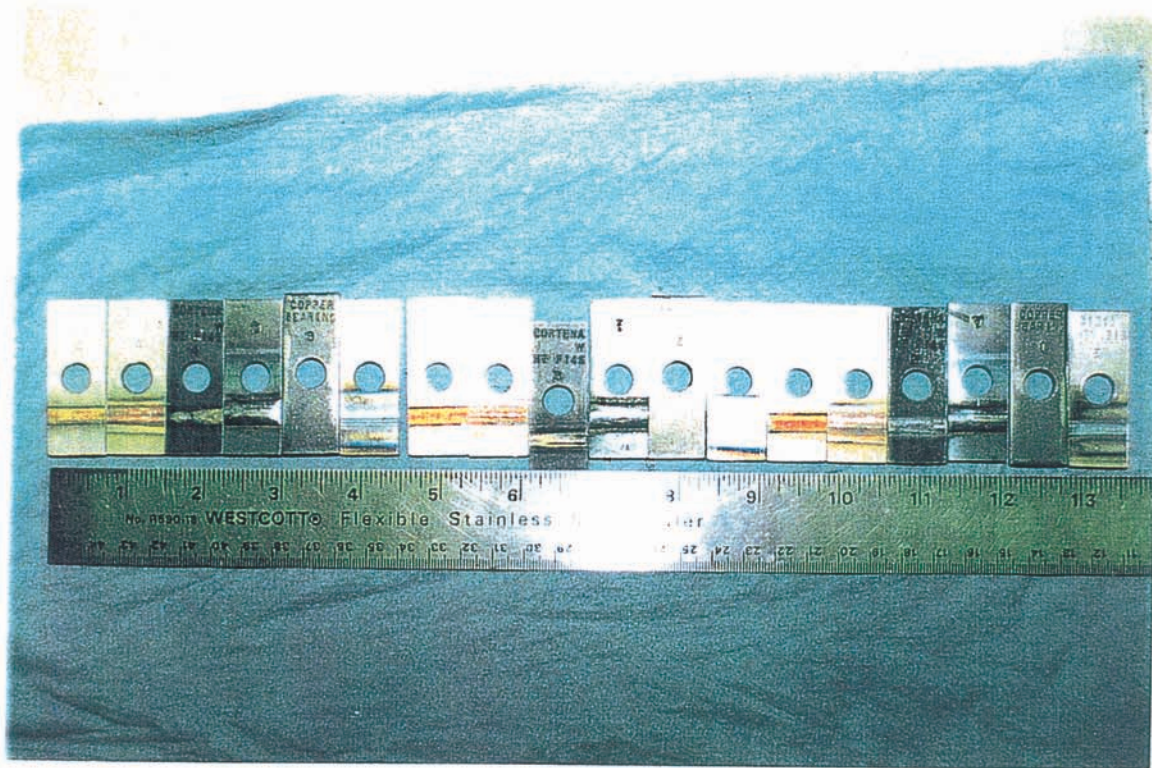
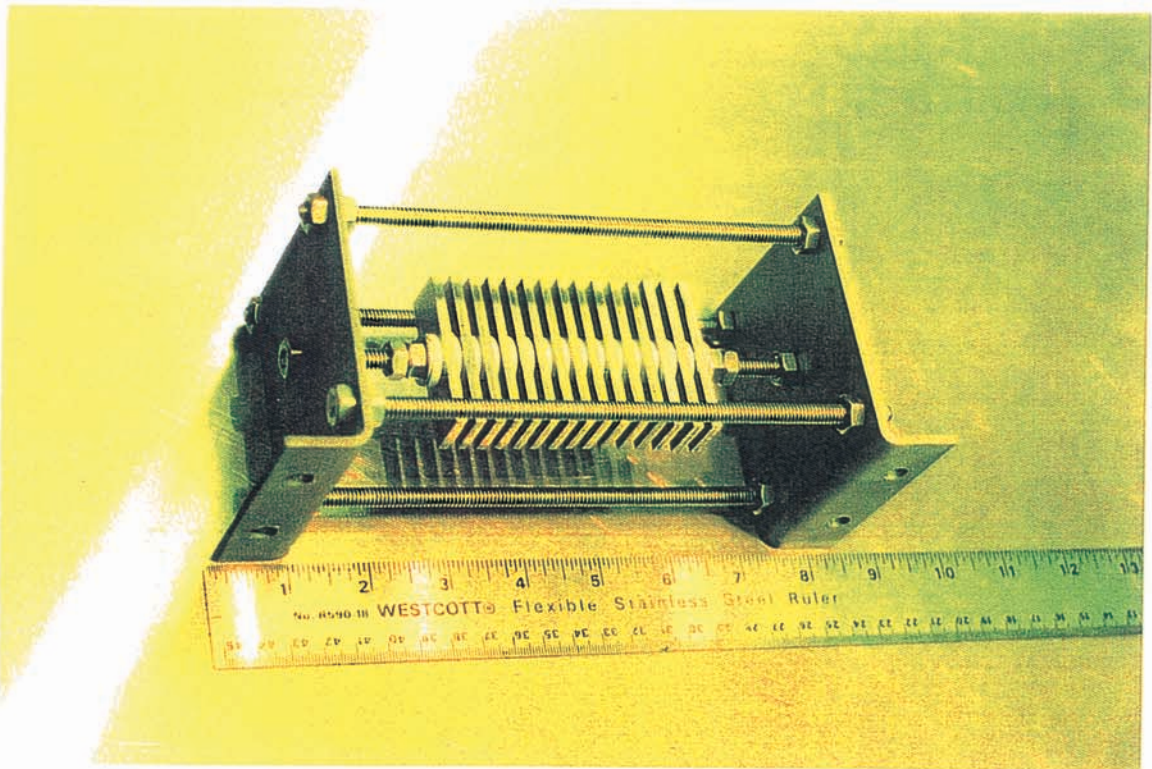
Figure 2

All coupons except for the Copper Bearing were manufactured by Metal Samples Co. in Munford, Alabama, and include an autogeneous weld. These four sets of four coupons are numbered 1-4 (no. 1 in each set is a reference coupon that was not placed downhole; no. 2 was exposed for 11 months, no. 3 for 11 weeks, and no. 4 for 7 weeks).

The coupons were placed in the well at a depth of 250 feet within a holding rack manufactured by Metal Samples Co. The coupons are separated by teflon spacers within a stainless steel 316L frame that is housed within plexiglass. The coupons and apparatus are shown in Figures 2 and 2a. The rack apparatus was lowered down the 18 inch diameter well using 1/8 in. stainless steel 304 cable. The coupons were retrieved using a 7/16 in. socket.

Metal Coupons Before Placement In Well No. 7

Coupons Inside Rack Apparatus

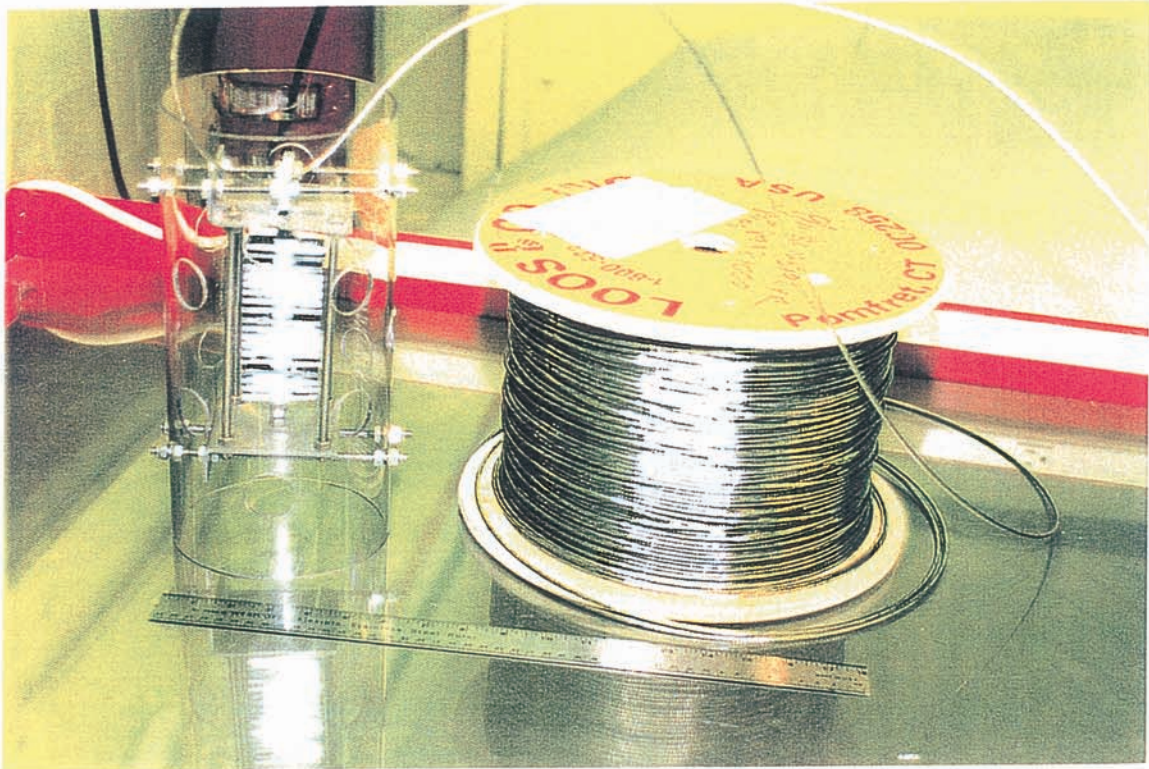
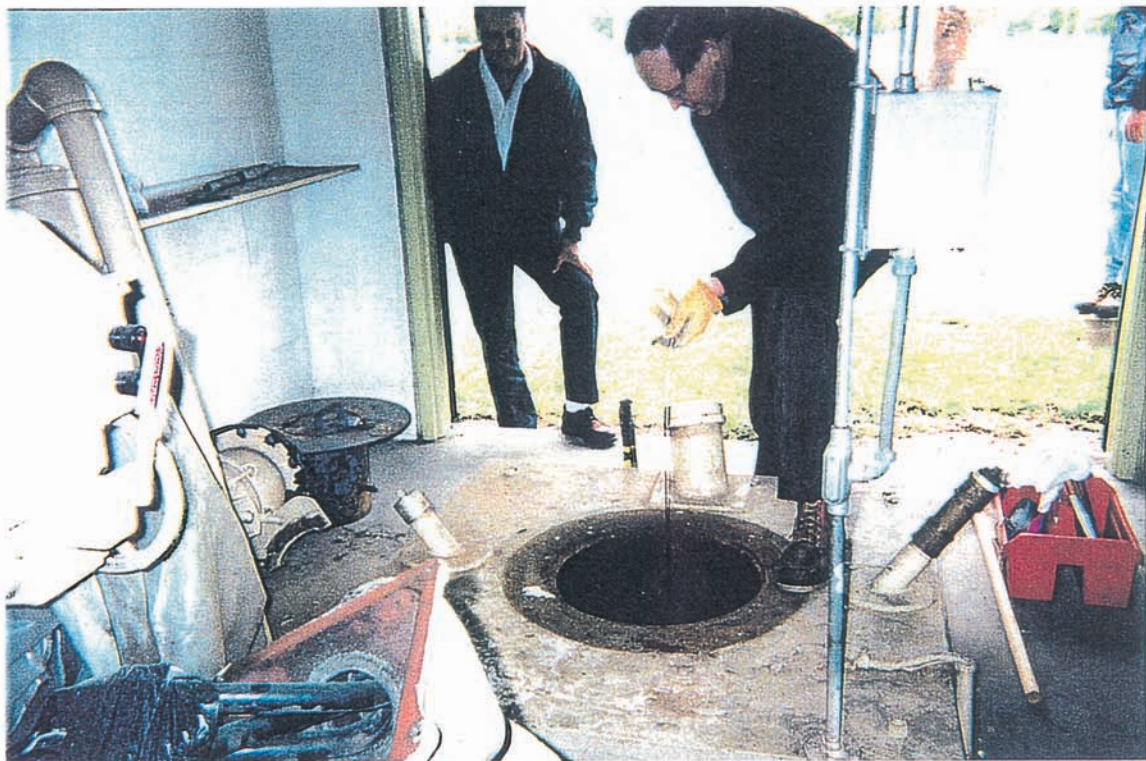
Figure 2a

Rack Apparatus and Cable

Lowering Coupons In Well No. 7

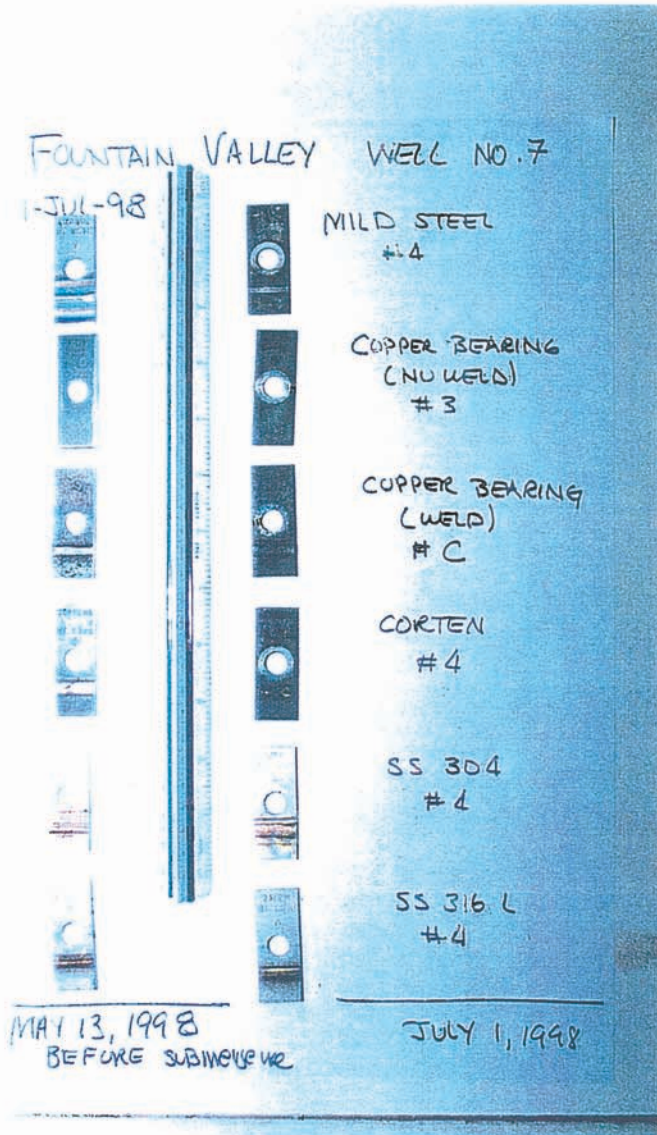
Figure 3

After seven weeks all the metal coupons except for the two stainless steel samples became black, though there was some discoloration on the weld bends of the stainless steel coupons (see Figure 3).

Reference Coupons (left) and Coupons After 7 Weeks Submersion (right)

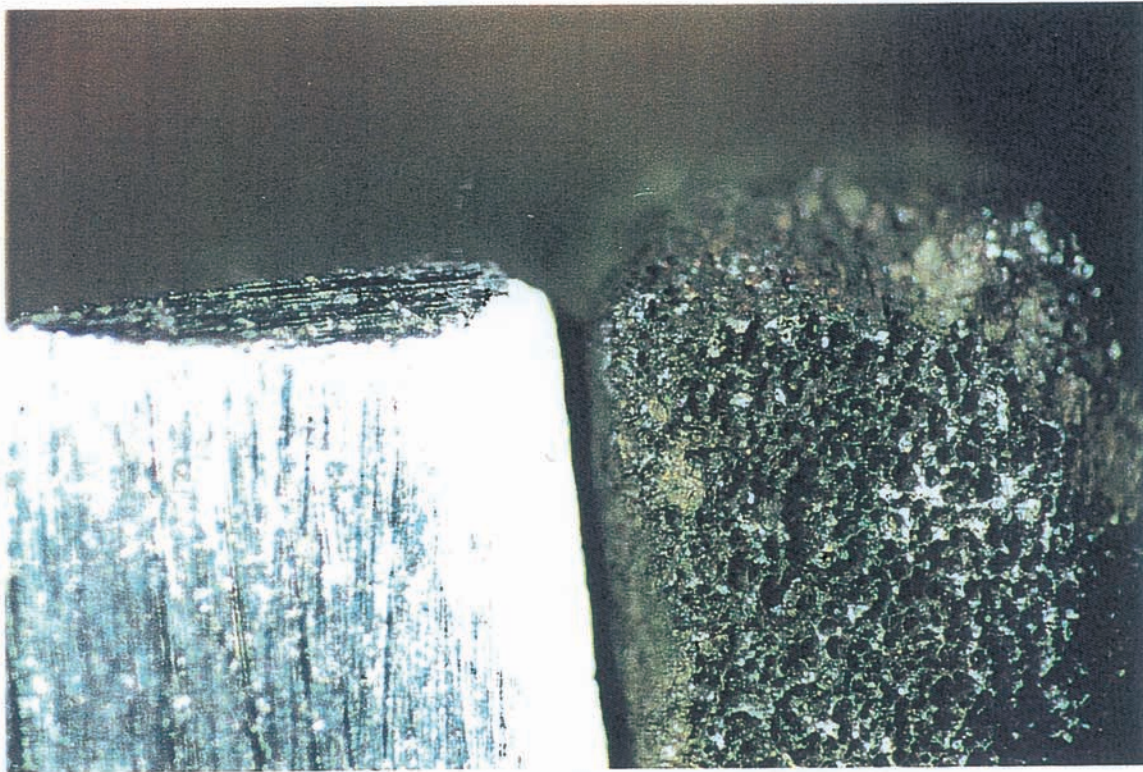
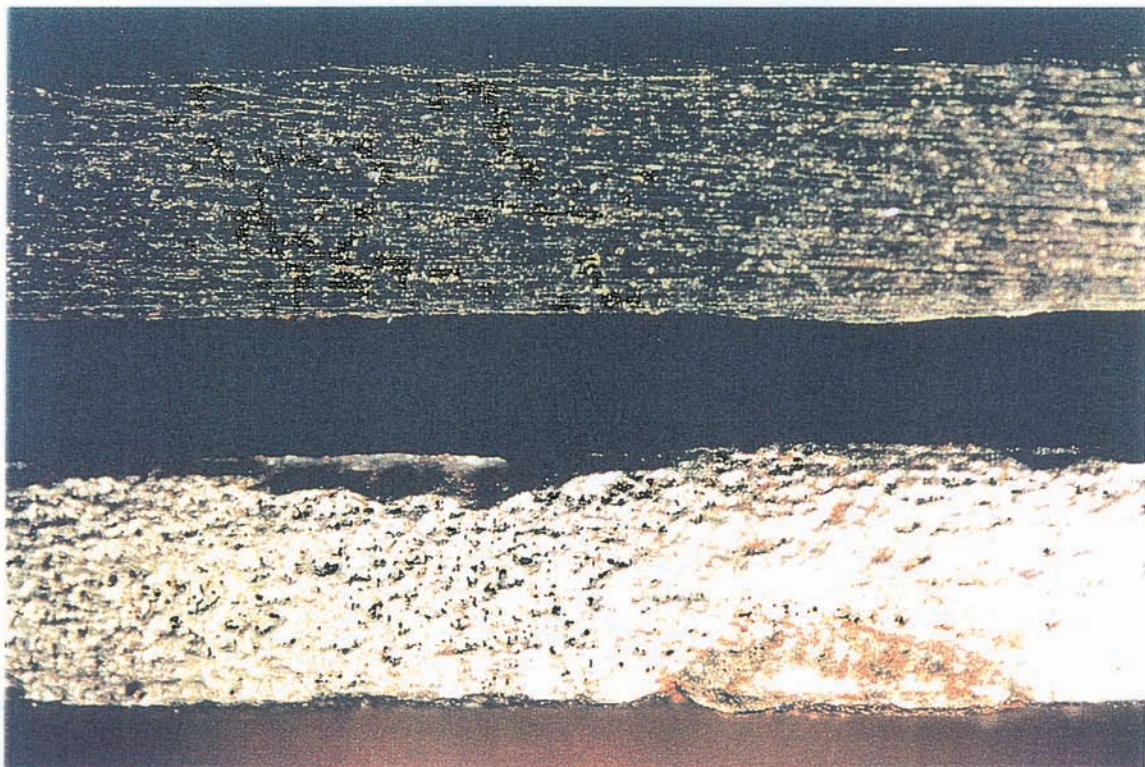
Figure 4

After eleven months downhole, the Mild steel underwent the most corrosion, becoming severely pitted (see Figures 4 and 4a). Scanning Electron Microscope (SEM) photographs of non-scale areas on the Mild steel coupon reveal iron oxide nodules and hexagonal crystals after eleven months that are not present on the reference coupon (see Appendix B, pages B-1 to B-2). SEM photographs of the scale on the Mild steel coupon show it consists of string-like material (see Appendix B, page B-4). Energy dispersive spectrometer (EDS) analysis reveals that the scale on the Mild steel coupon contains elevated calcium, silicon, oxygen, and sulfur levels compared to the reference coupon (see Appendix C, pages C-2 to C-4).

**Mild Steel Coupons
After 11 Months Submergence**

Reference (left) and Severely Pitted Mild Steel (right, x 3.5)

Reference (above) and Pitted Mild Steel (side view)

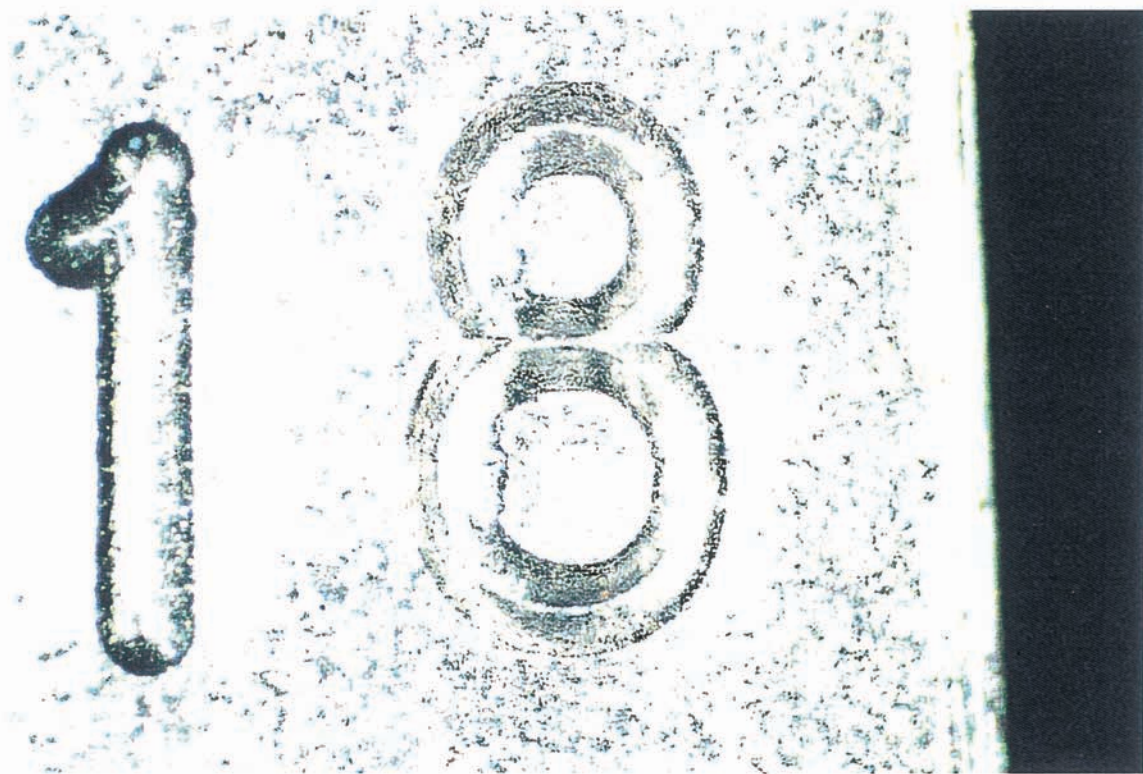
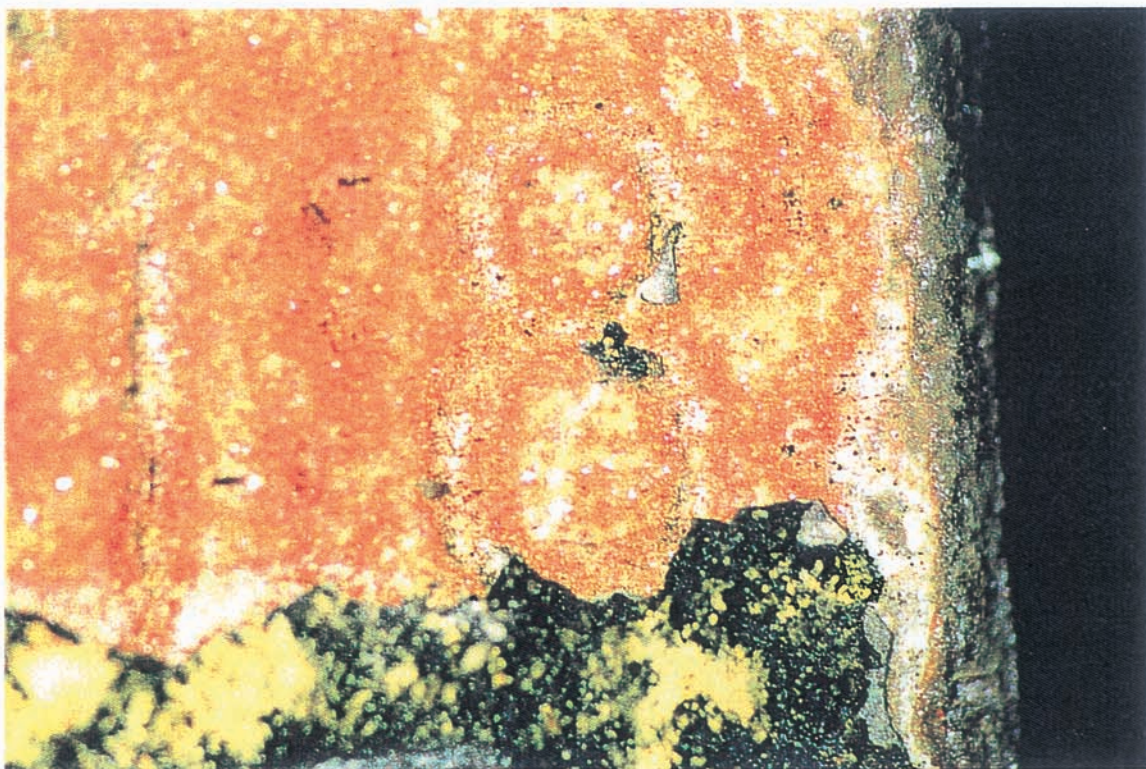
Figure 4a

Mild Steel Coupons
After 11 Months Submergence

Before (x 3.5)

After (x 3.5)

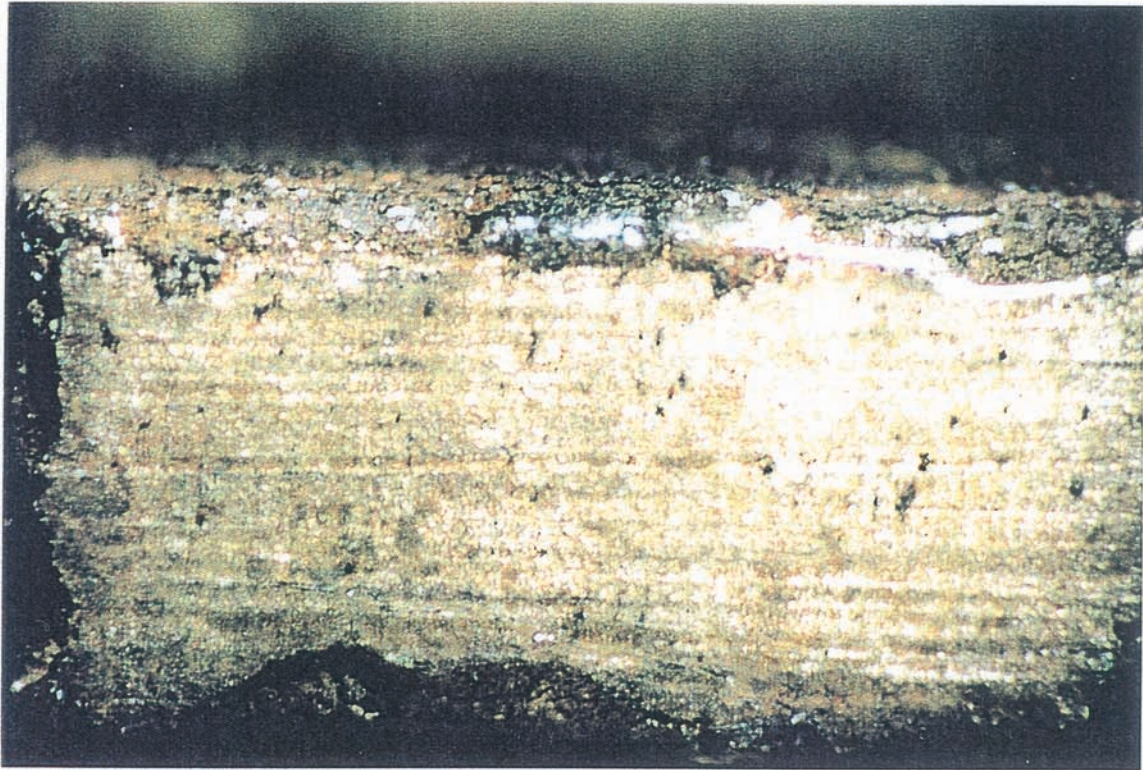
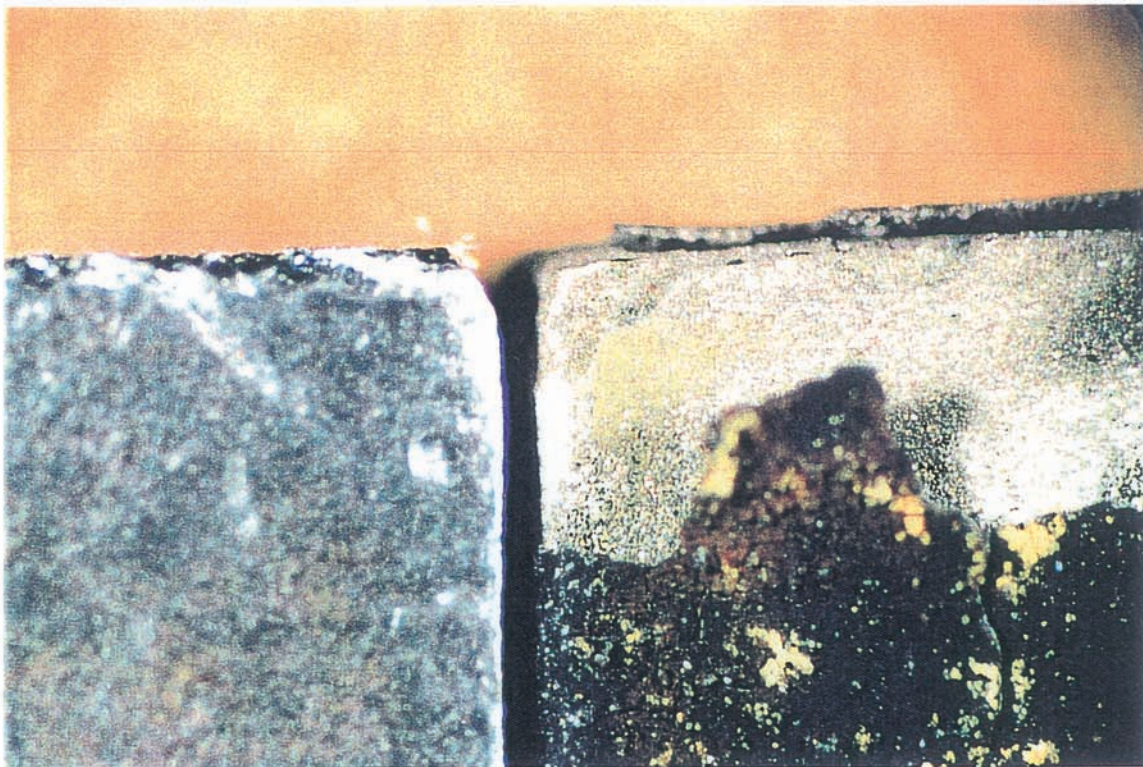
Figure 5

The Copper Bearing and Corten coupons suffered spotty etch and areas of attack. SEM photographs reveal the grain boundaries of the Corten to be more disfigured after eleven months than grain boundaries in the stainless steel coupons (see Appendix B). Light microscope photographs showing the Copper Bearing and Corten steel coupons after eleven months of submergence (before cleaning) can be found in Figure 5.

**Corten and Copper Bearing Steel Coupons
After 11 Months Submergence**

Corten Steel Coupon (x 3.5)

**Copper Bearing Steel Coupon (x 3.5), Reference (left) and Field
Coupon (right)**

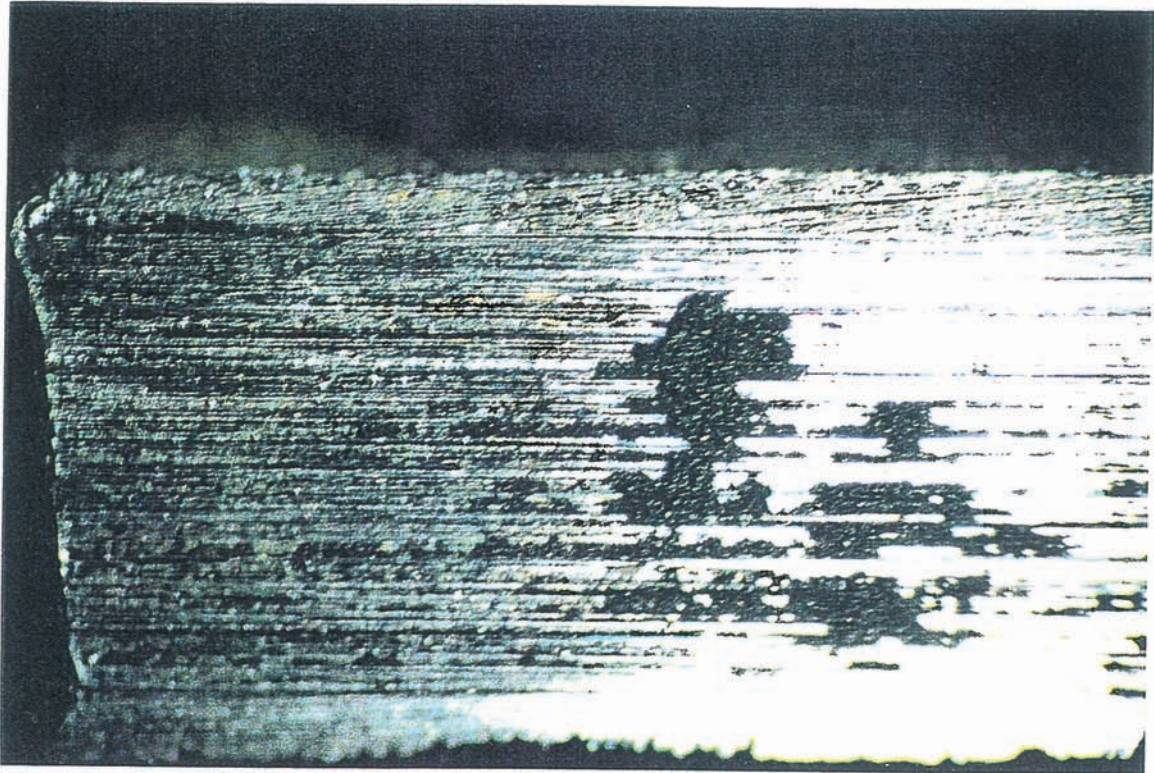
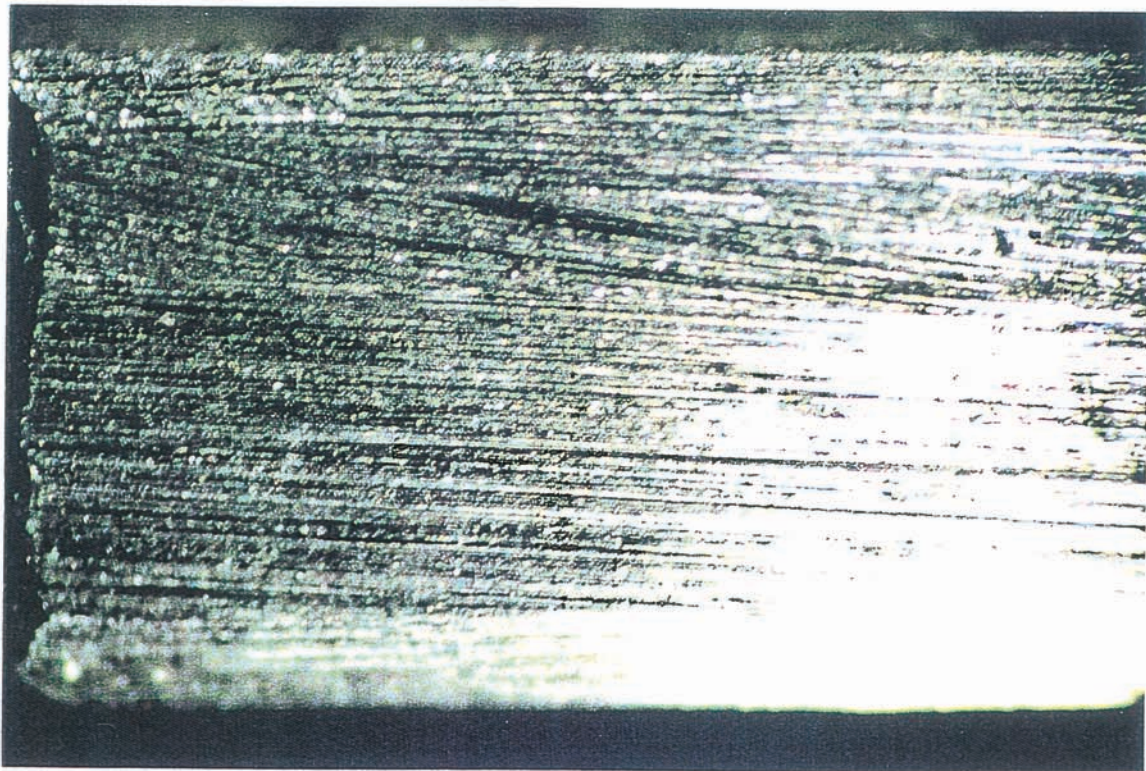
Figure 6

The stainless steel coupons suffered the least corrosion, classified as even etch. The scale area on the stainless steel 316L coupon is characterized by elevated oxygen, sulfur, silicon, and calcium levels compared to the reference coupon. Non-scale areas nearly perfectly retain the same chemical signature as the reference coupon as determined by EDS (see Appendix C). Light microscope photographs showing the stainless steel coupons after eleven months of submergence (before cleaning) can be found in Figures 6 and 6a.

**Stainless Steel Coupons
After 11 Months Submergence**

Stainless Steel 304 (x 3.5)

Stainless Steel 316L (x 3.5)

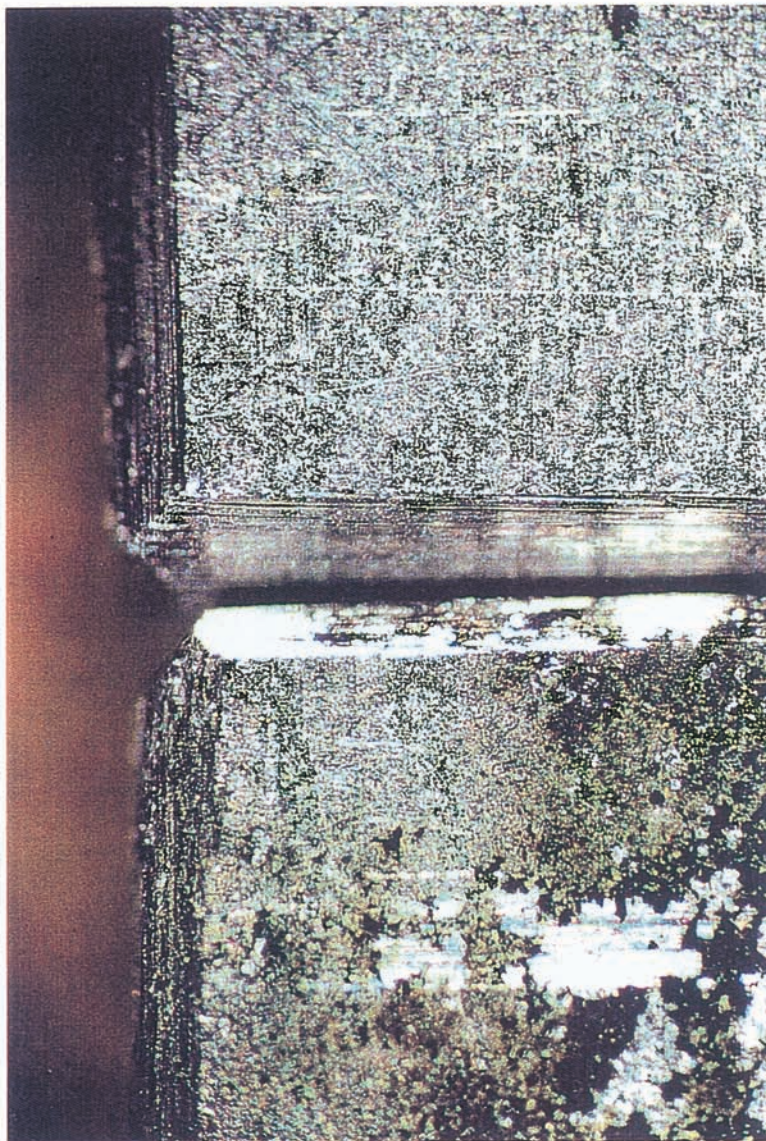
Figure 6a

**Stainless Steel Coupons
After 11 Months Submergence**

**Stainless Steel 316L (x 3.5),
Reference (above) and Field Coupon (below)**

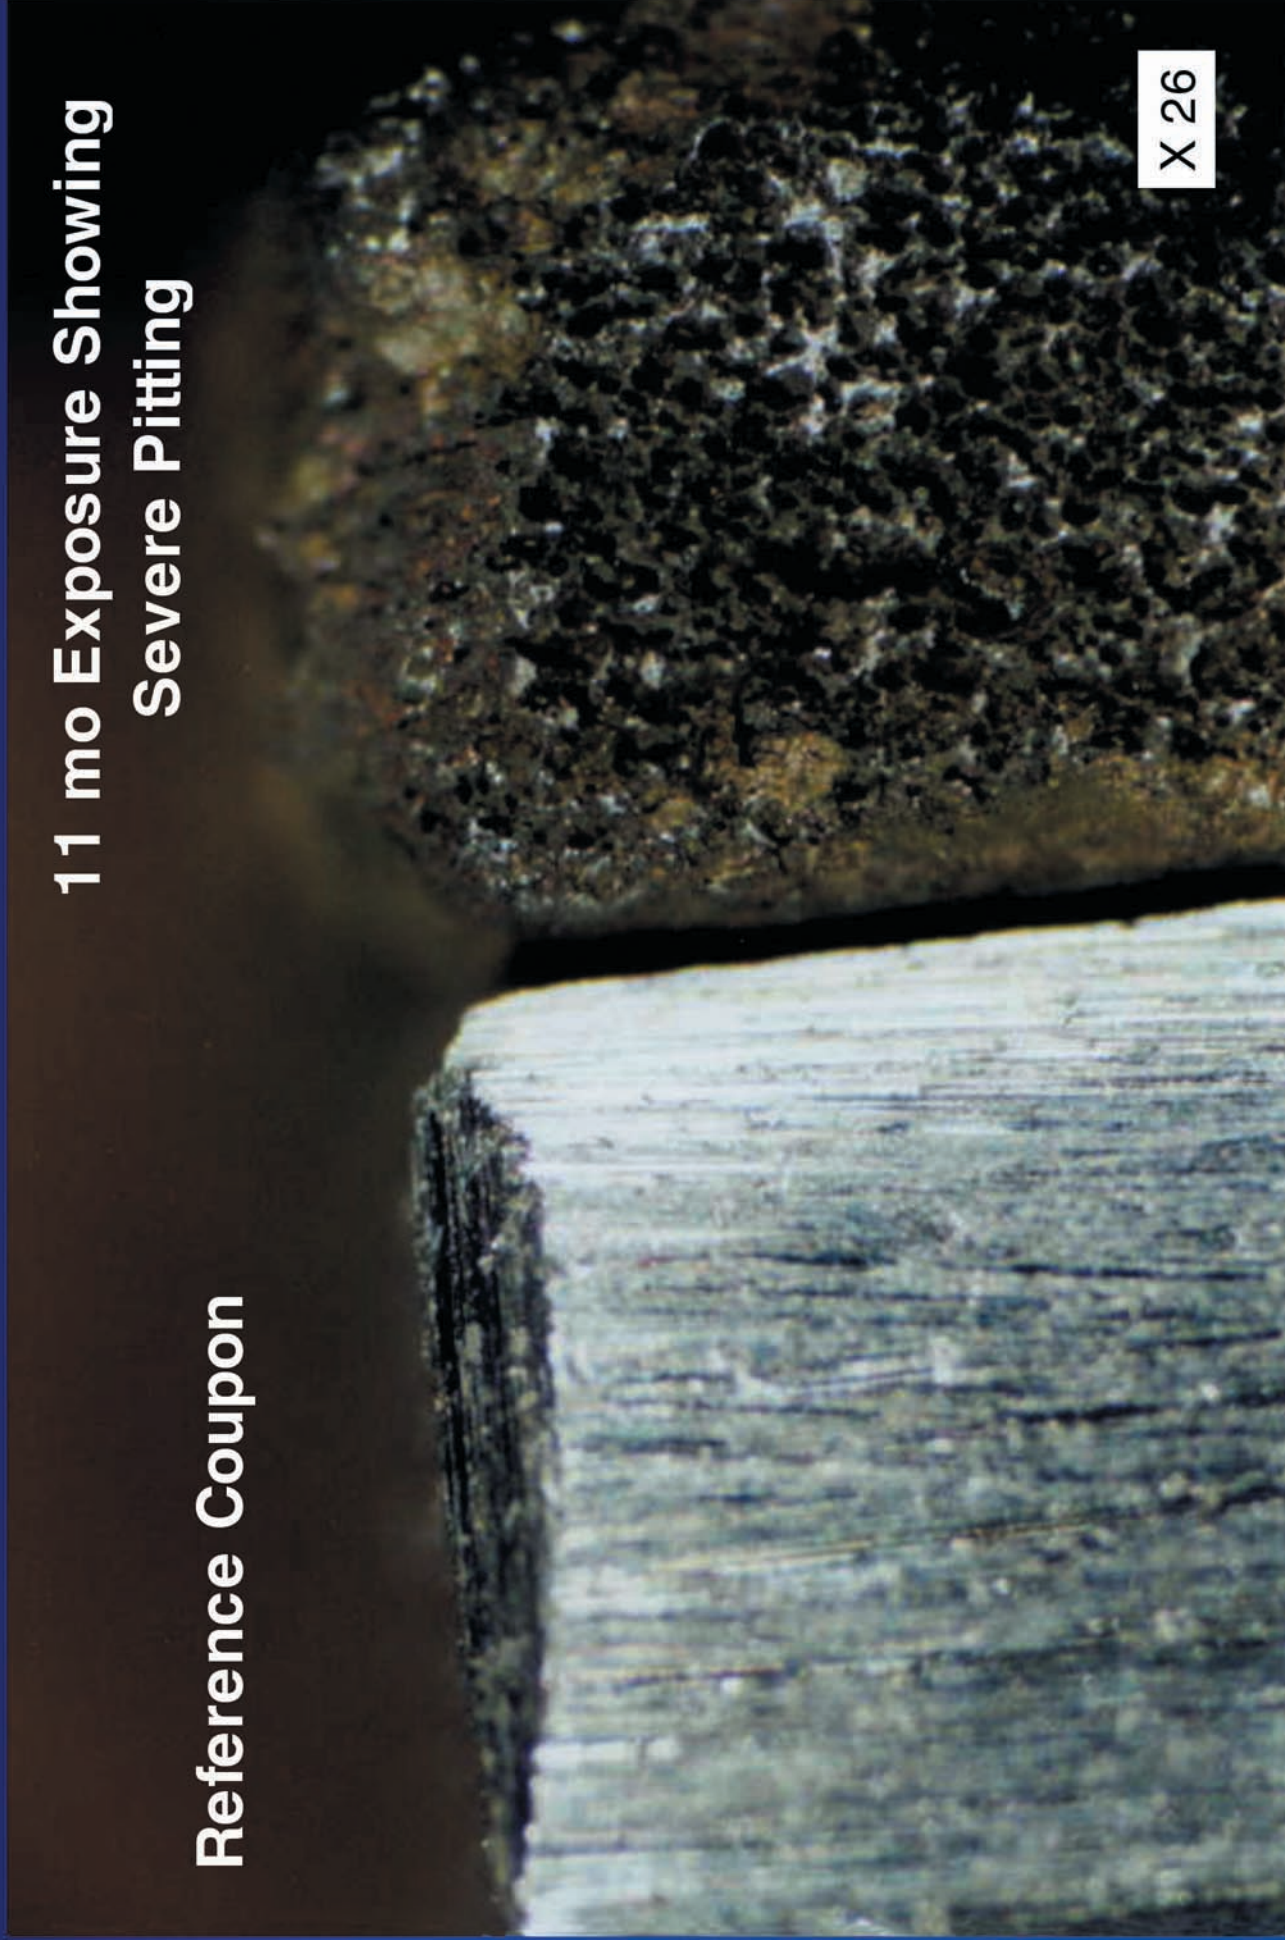
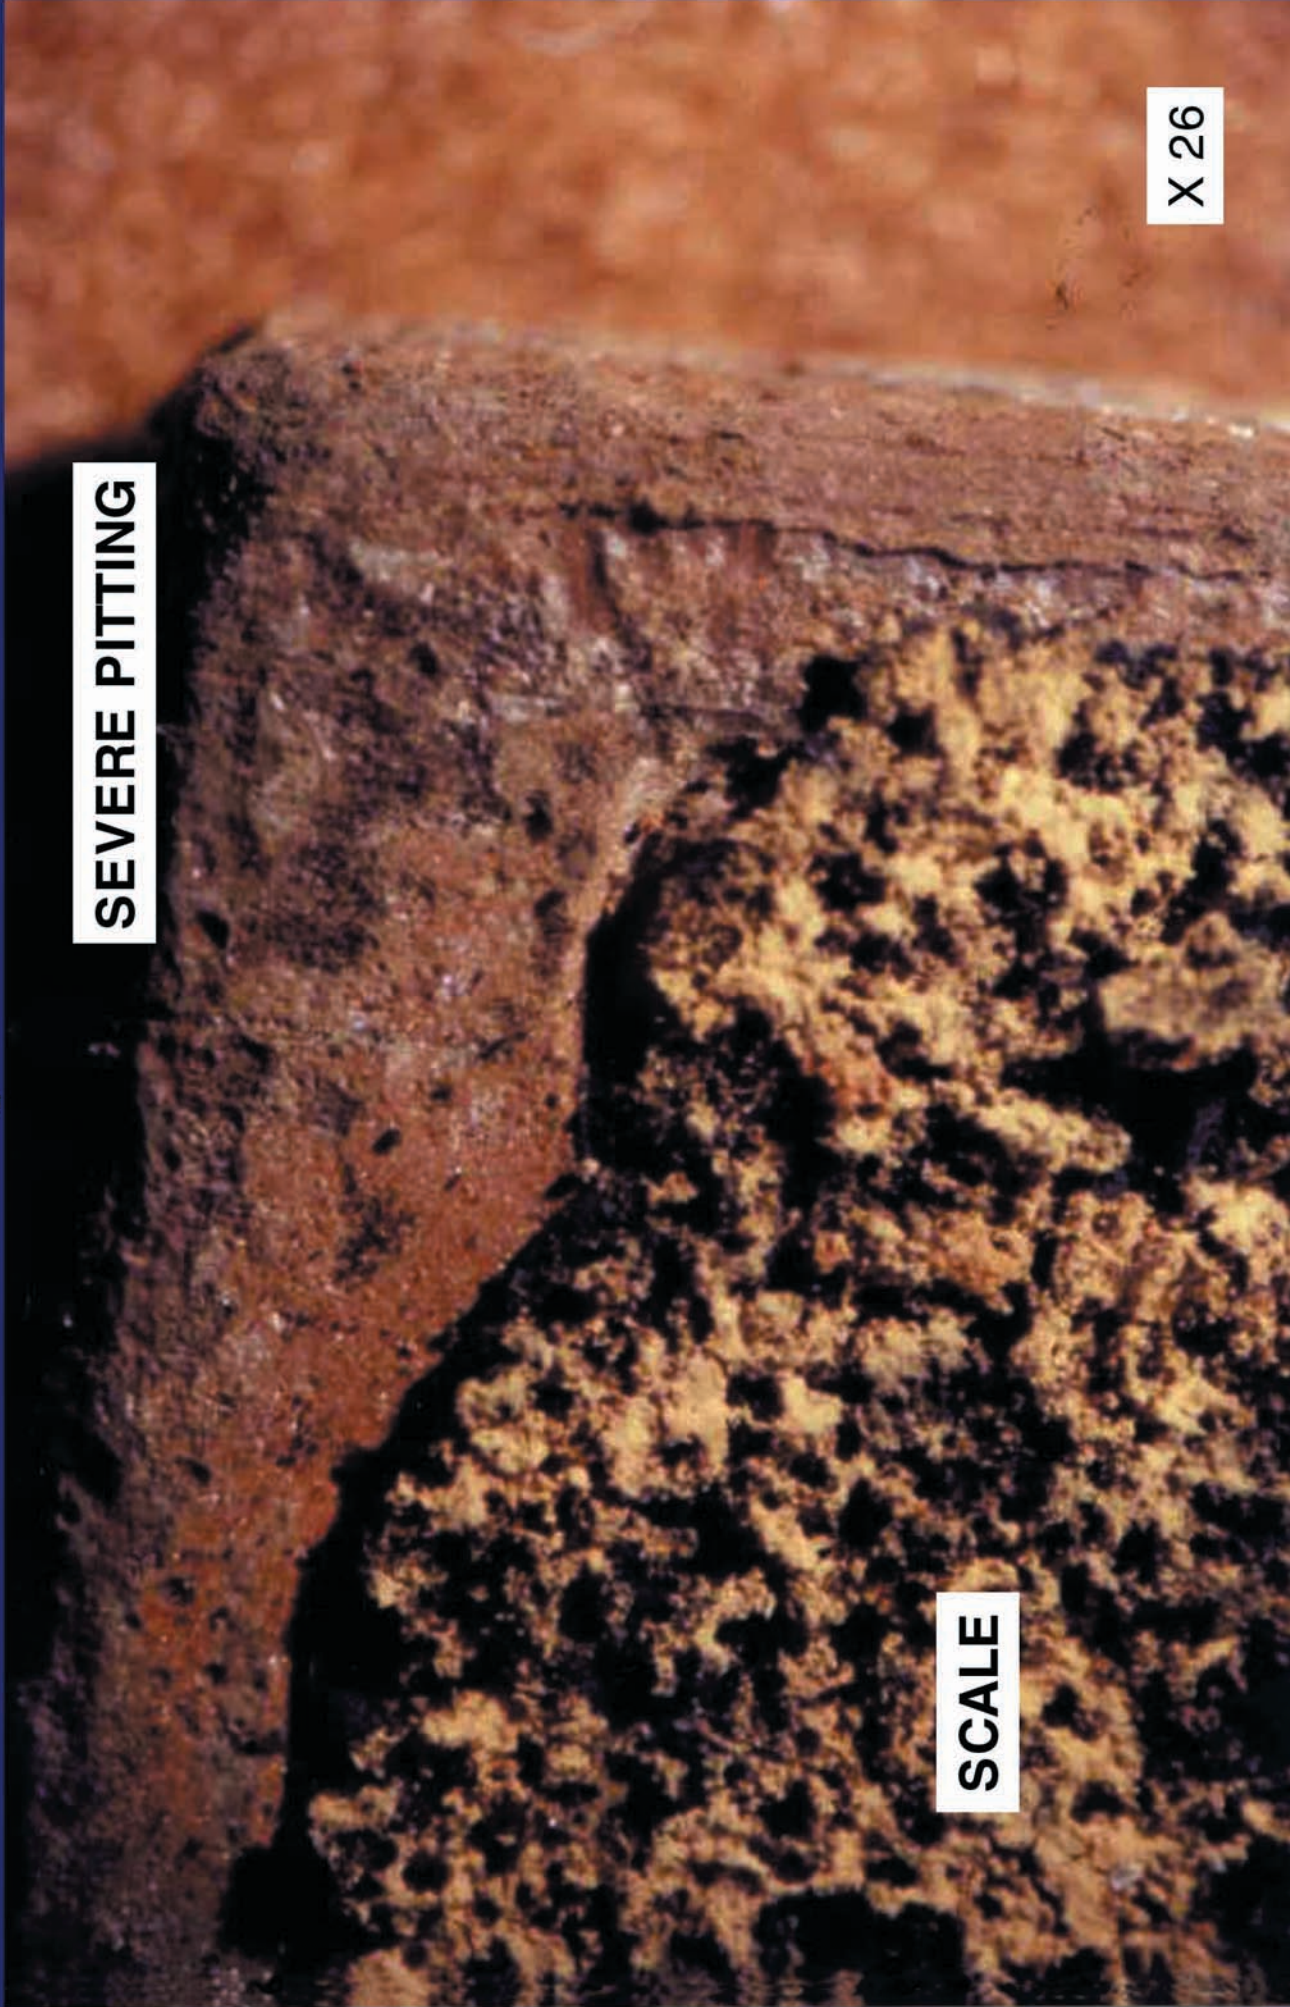
Light Microscope Photographs - Mild Steel

11 mo Exposure Showing
Severe Pitting

Mild Steel Coupon After 11 Months

SEVERE PITTING

SCALE

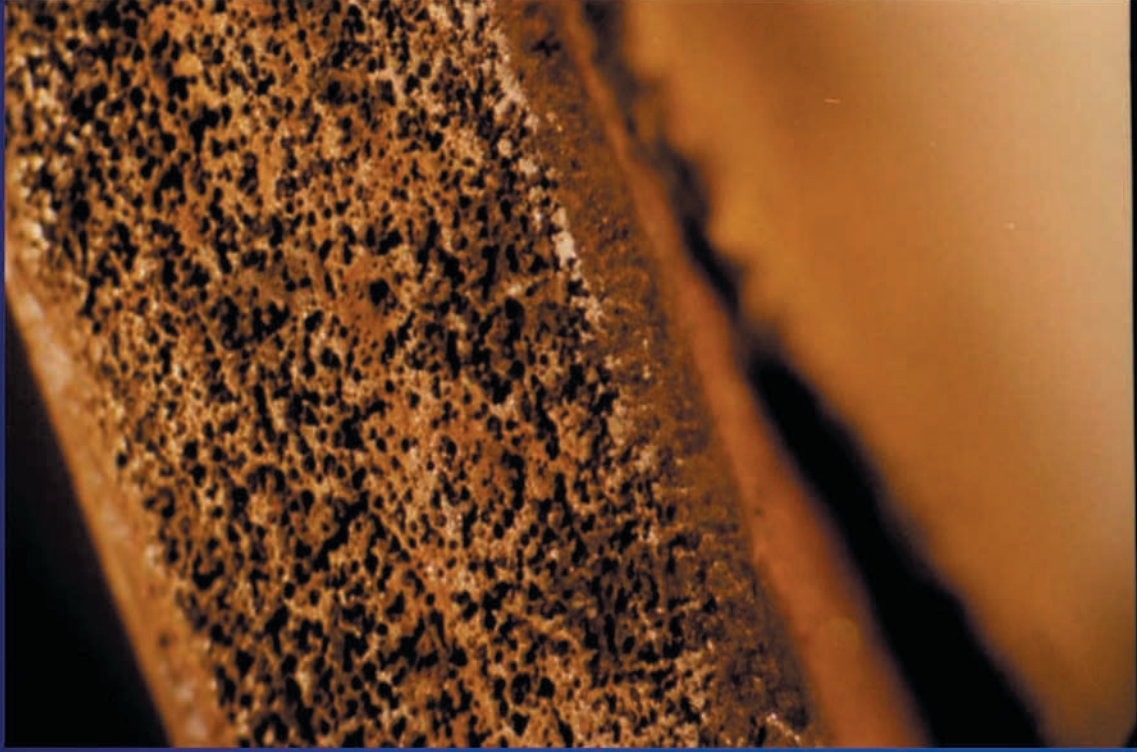
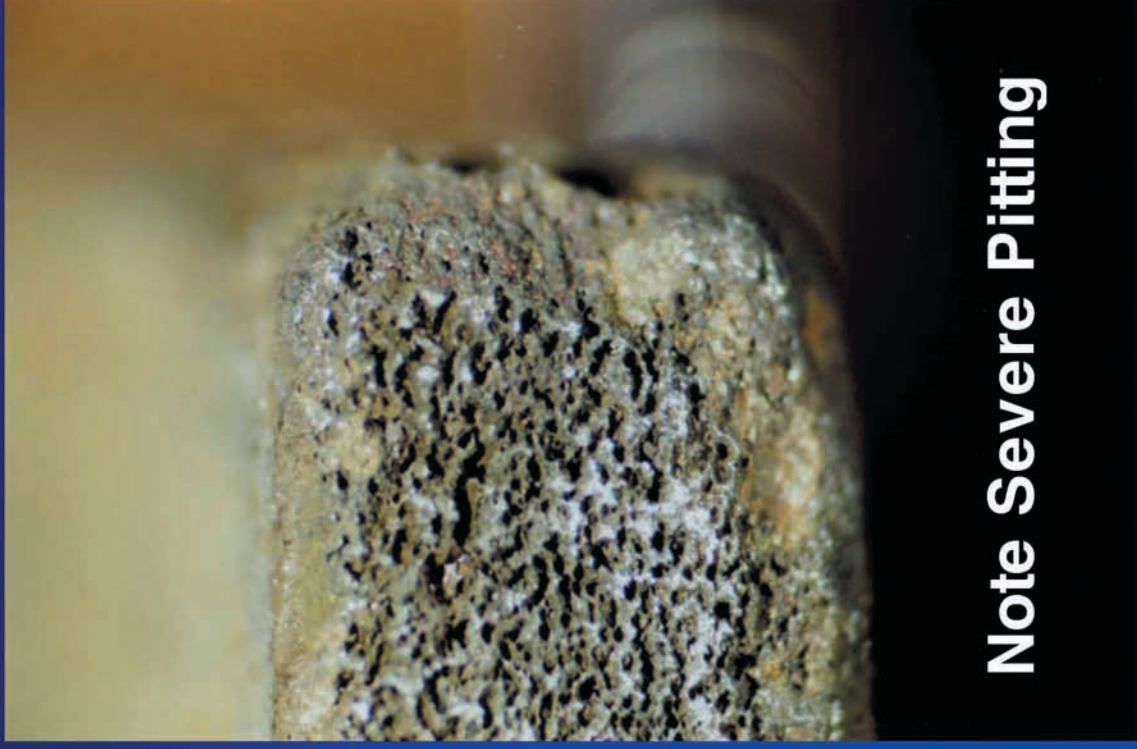
Mild Steel After 11 Mo. Exposure

Note Severe Pitting
