CORROSION FIELD TEST OF STEELS COMMONLY USED IN WELL CASING AND SCREEN

City of Fountain Valley

July 29, 1999

WELL NO. 7

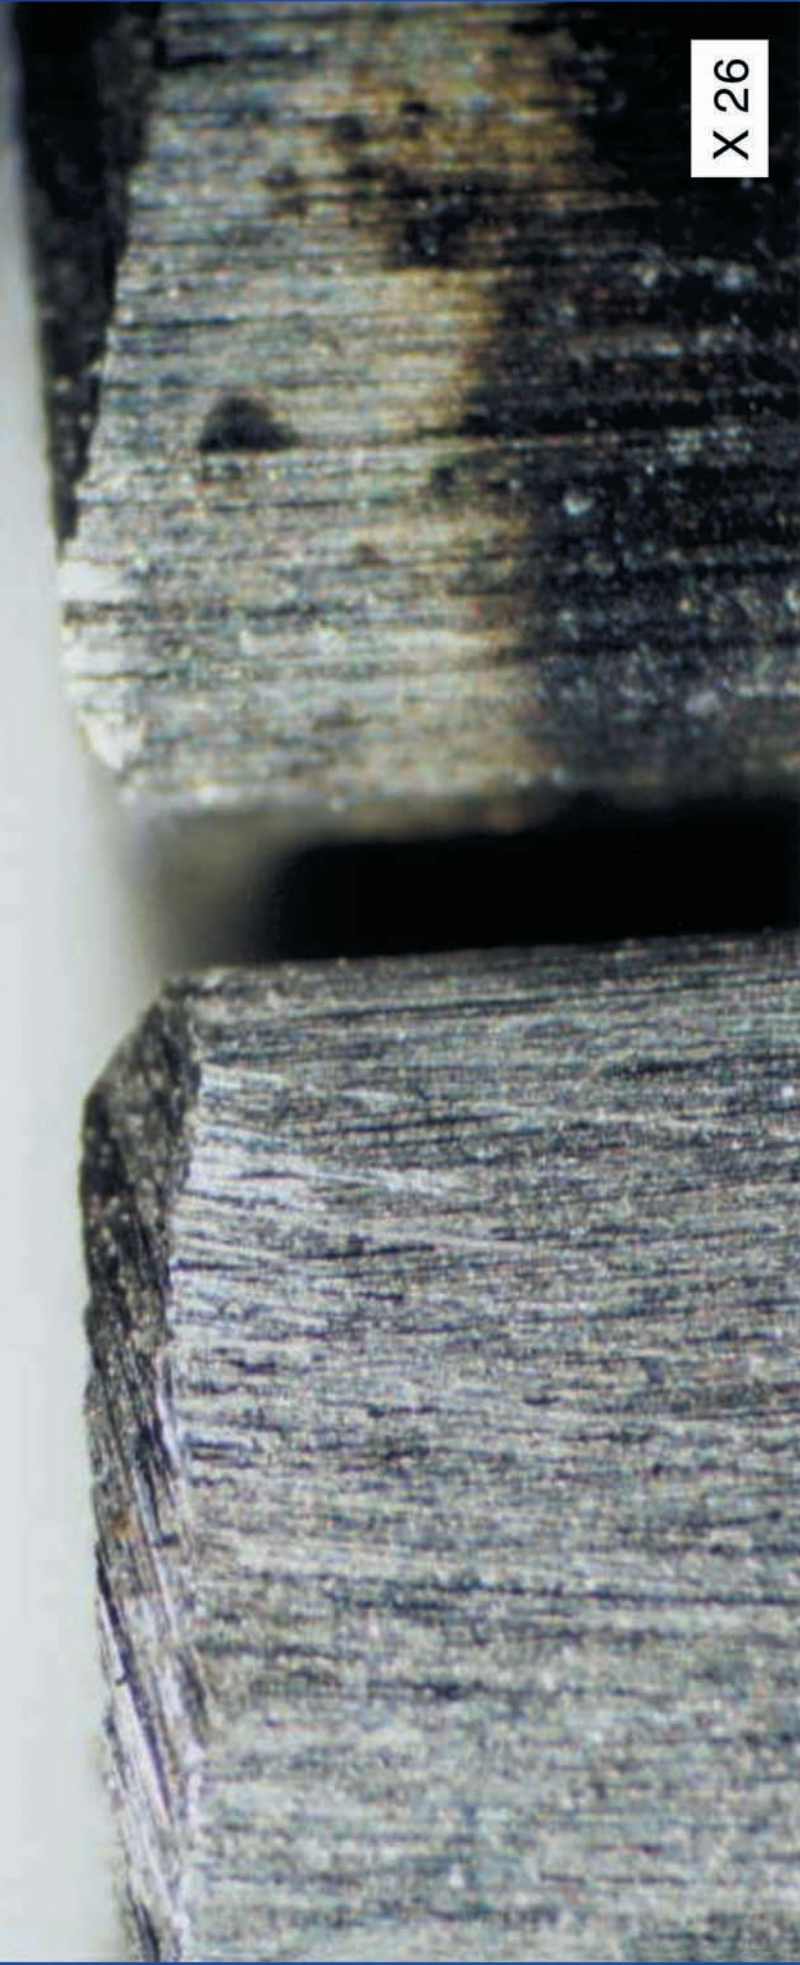
Stainless Steel 316L

Reference Coupon

11 mo Exposure

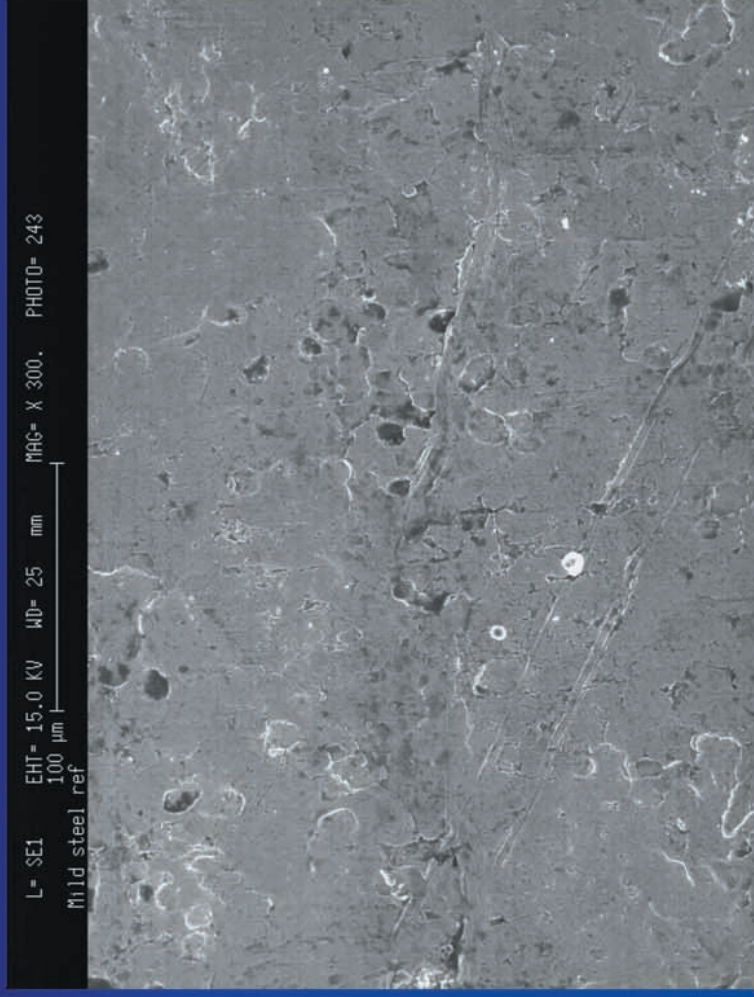
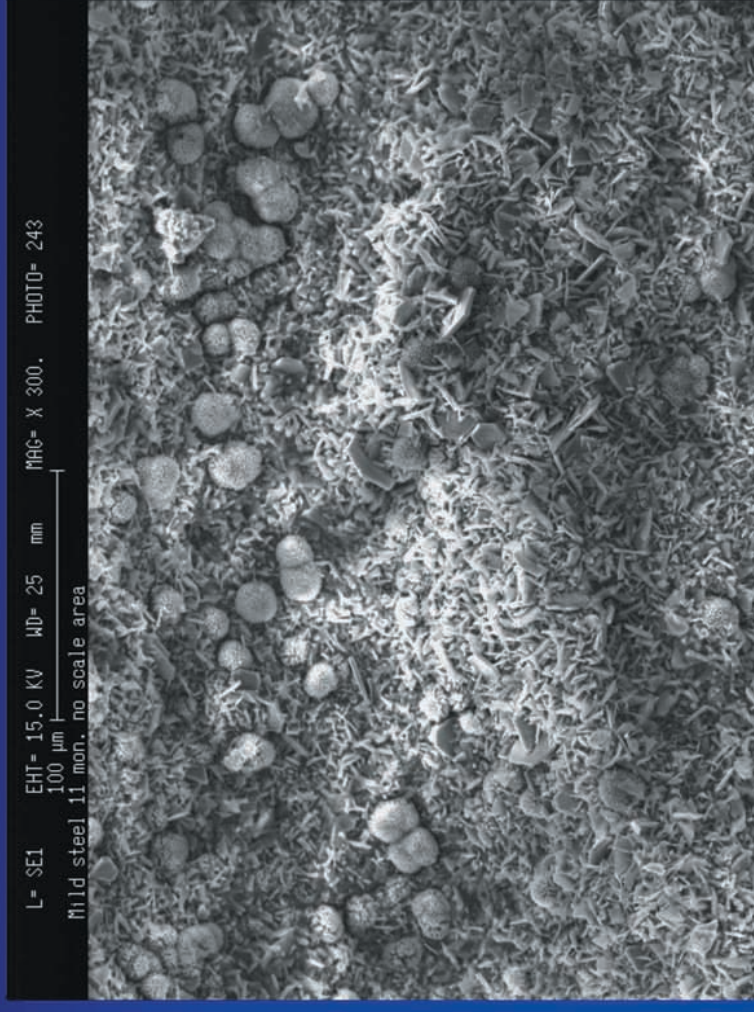
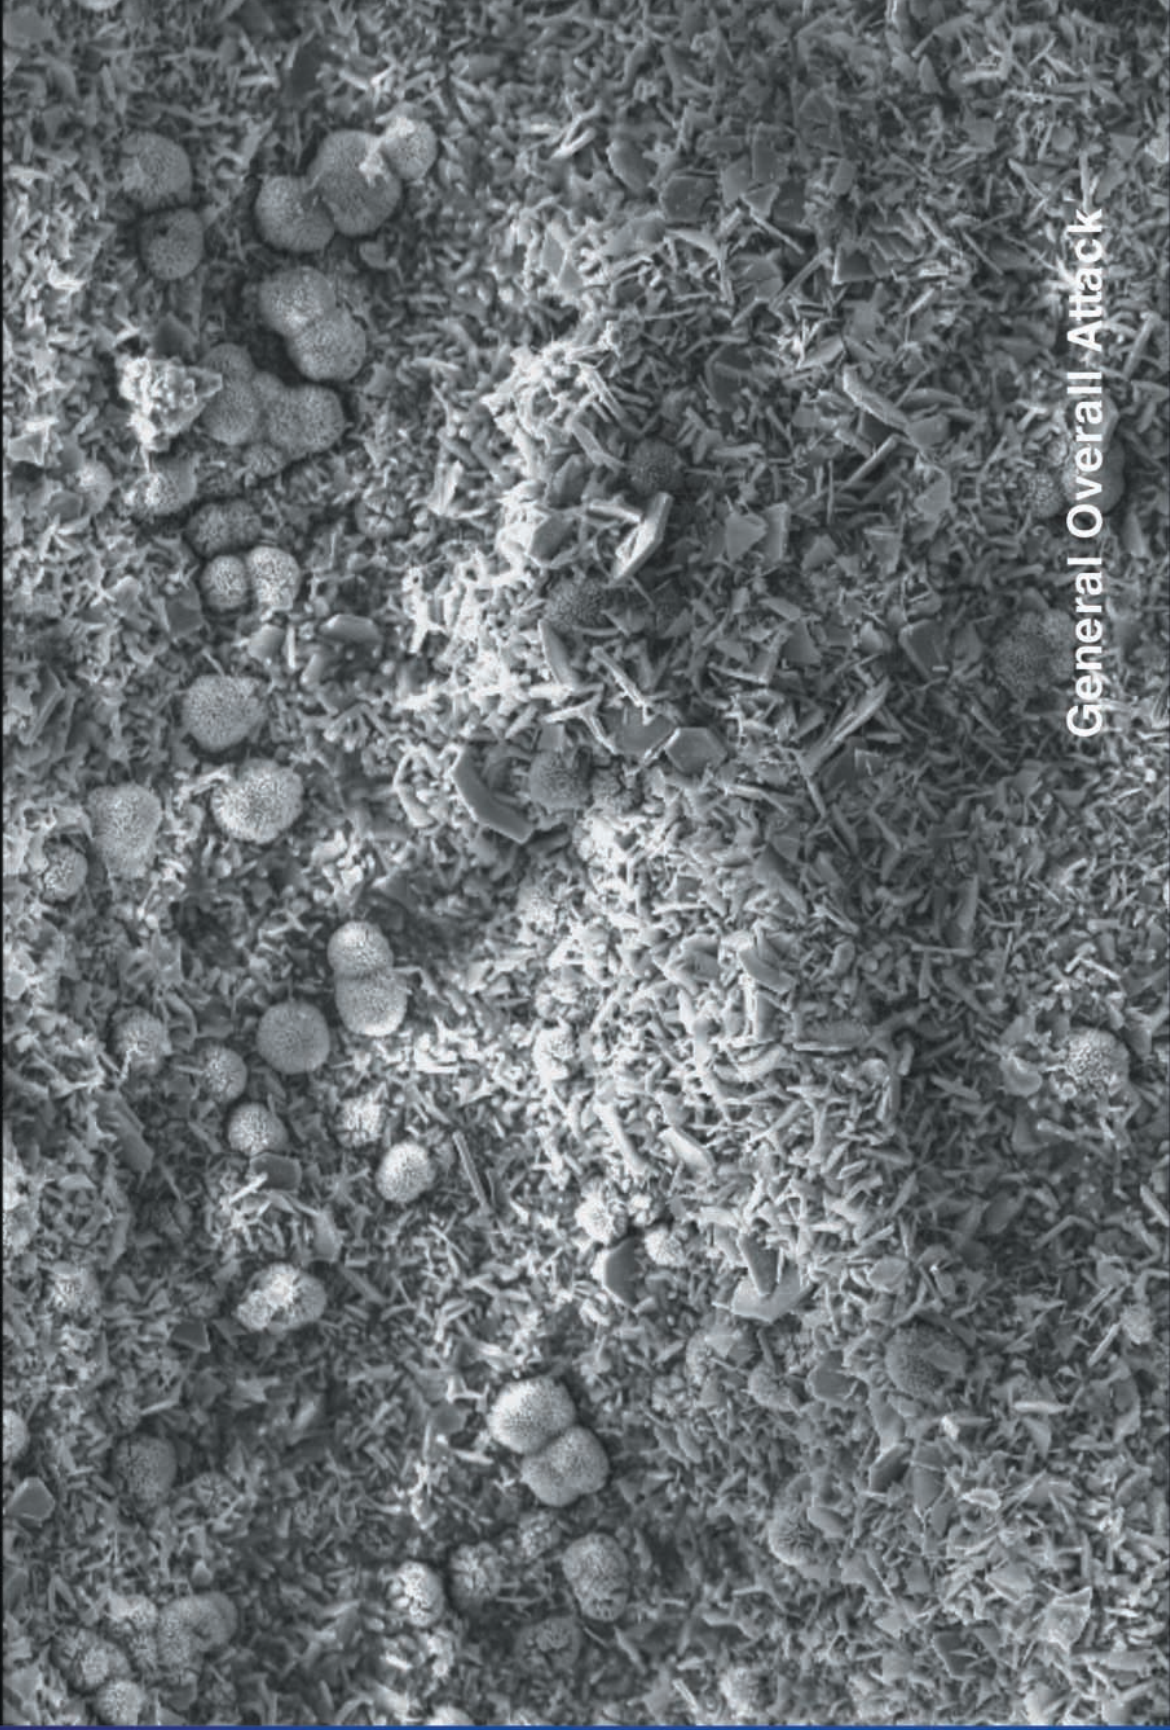
After eleven months downhole, the Mild steel underwent the most corrosion, becoming severely pitted (see Figures 4 and 4a). Scanning Electron Microscope (SEM) photographs of non-scale areas on the Mild steel coupon reveal iron oxide nodules and hexagonal crystals after eleven months that are not present on the reference coupon (see Appendix B, pages B-1 to B-2). SEM photographs of the scale on the Mild steel coupon show it consists of string-like material (see Appendix B, page B-4). Energy dispersive spectrometer (EDS) analysis reveals that the scale on the Mild steel coupon contains elevated calcium, silicon, oxygen, and sulfur levels compared to the reference coupon (see Appendix C, pages C-2 to C-4).

Scanning Electron Microscope (SEM) - Mild Steel

General Overall Attack

Iron Oxide
Nodules And
Hexagonal
Crystals

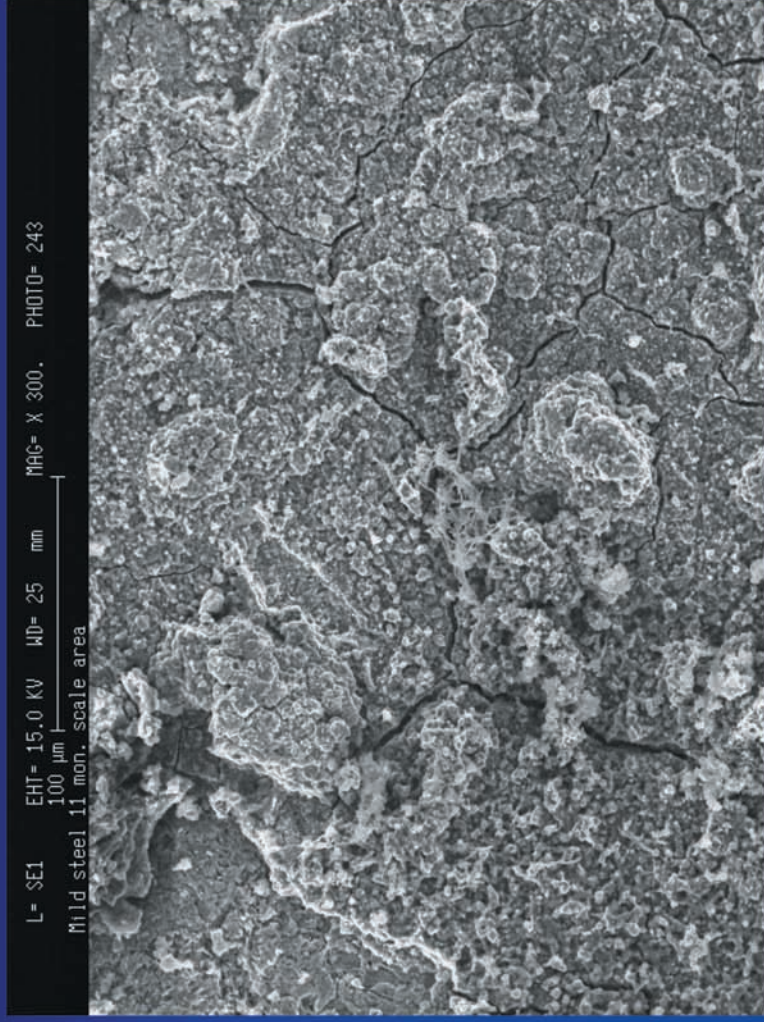
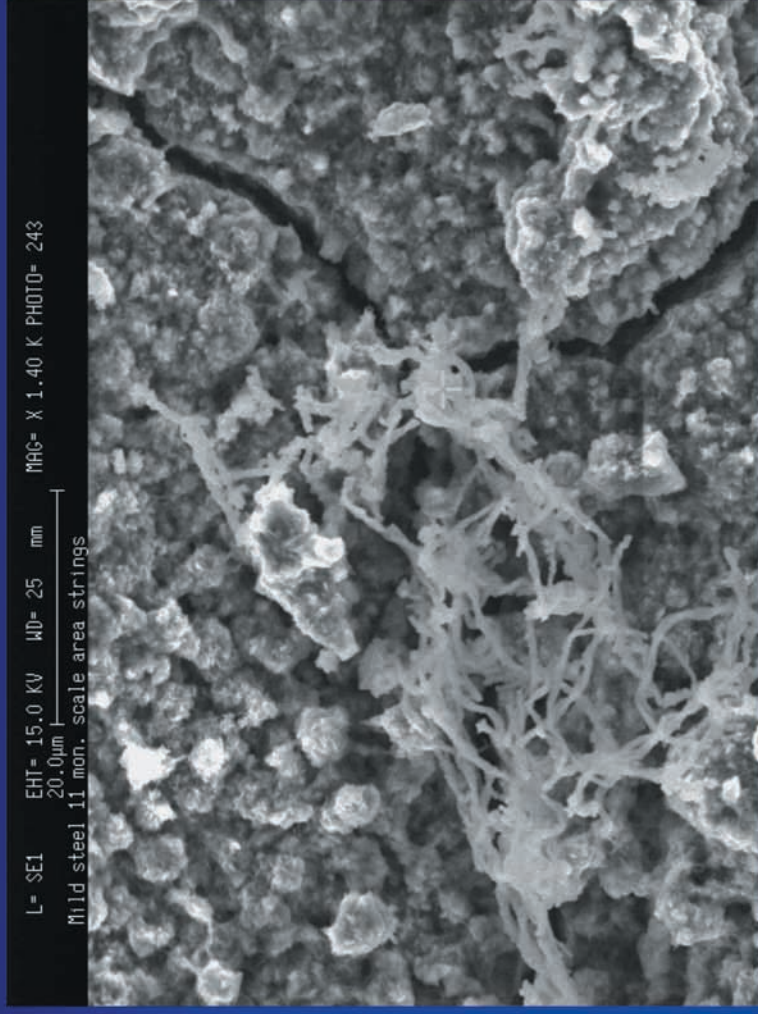
Scanning Electron Microscope - Mild Steel

11-Mo Exposure

Scale

Note "String"
Like Material

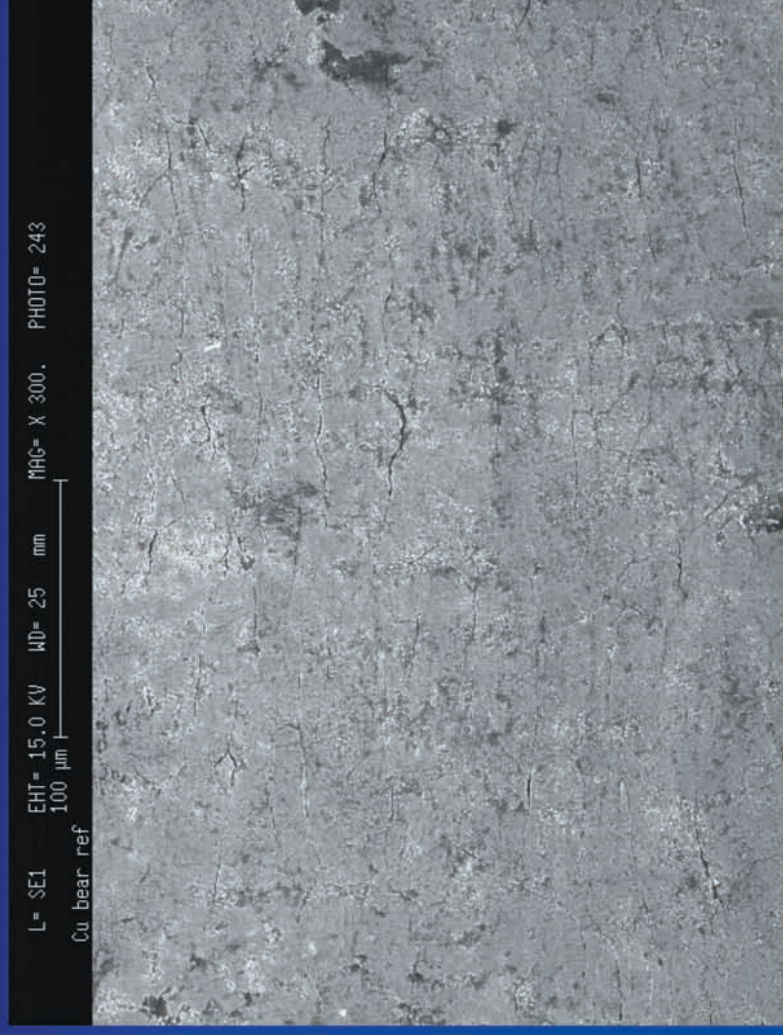
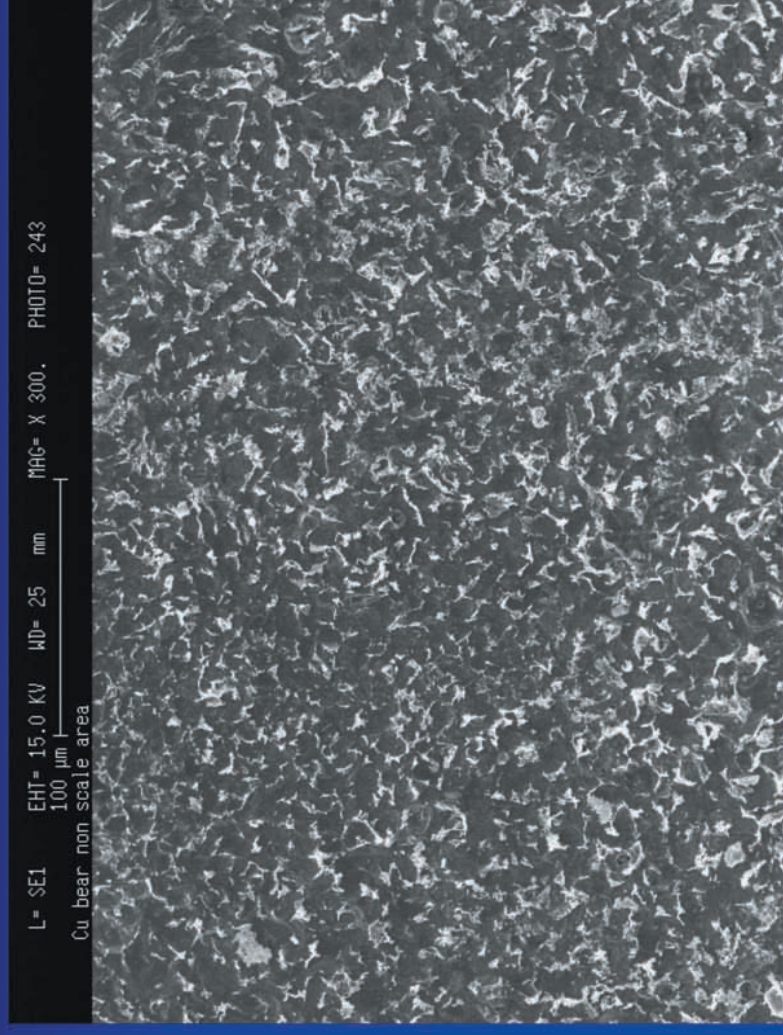
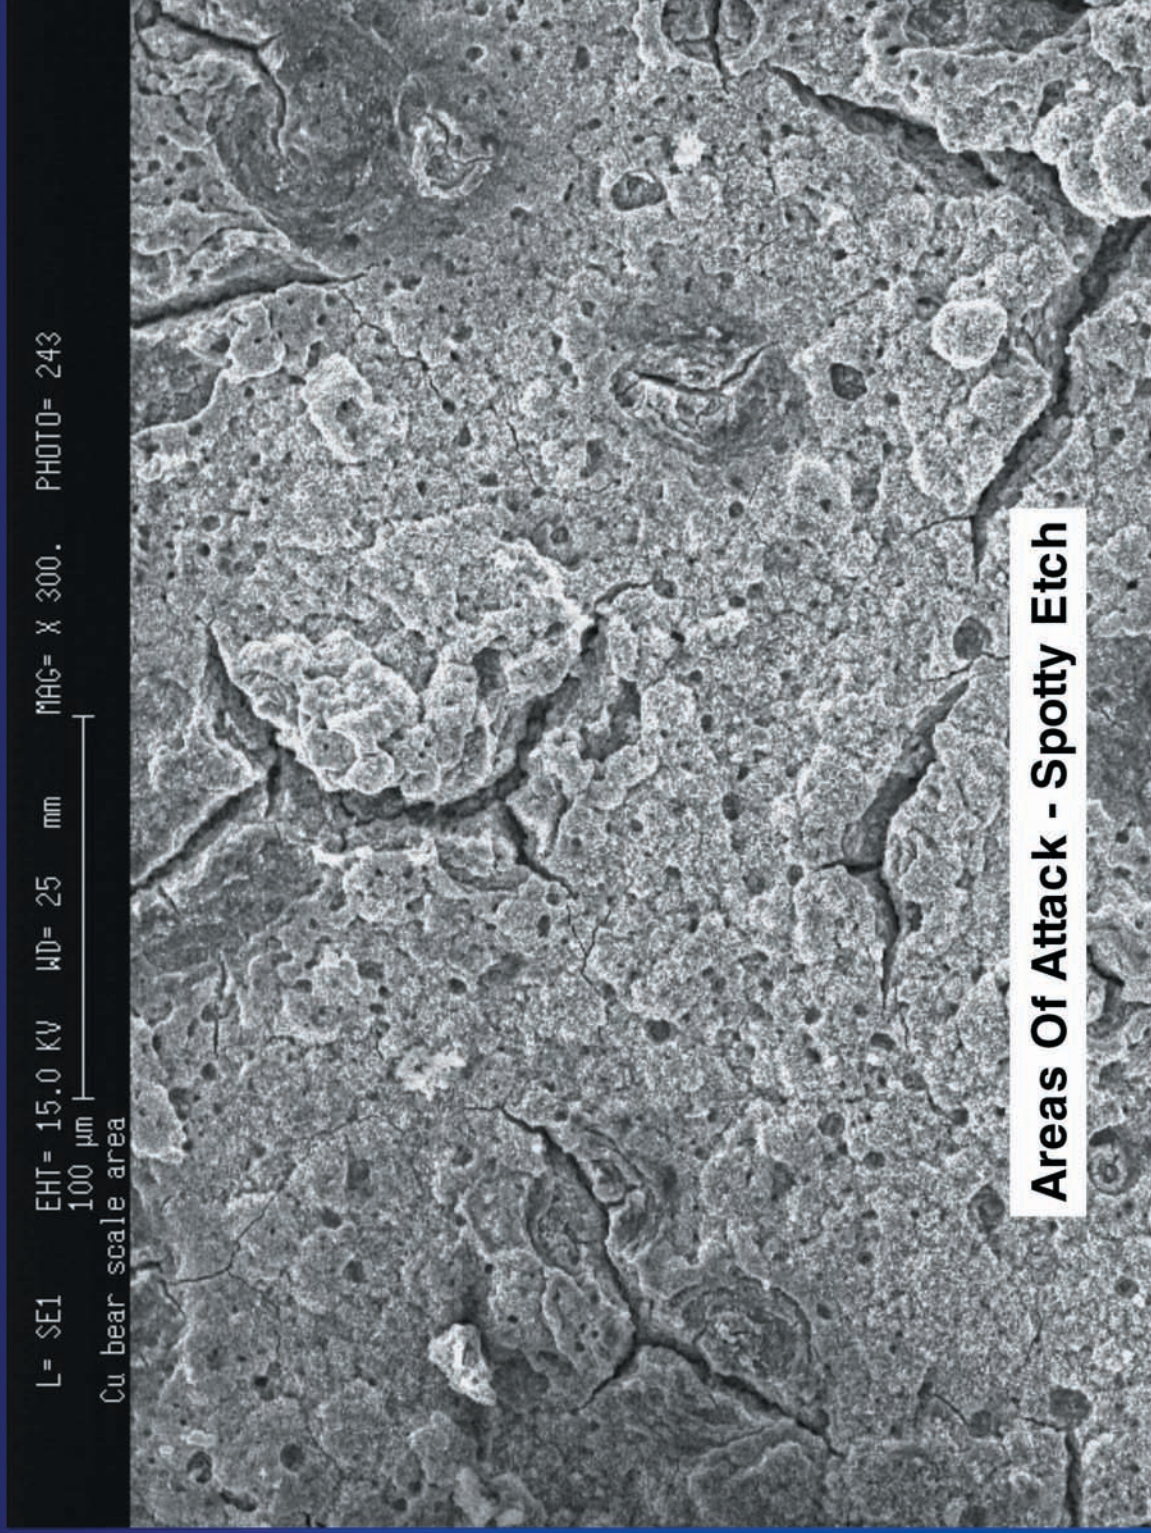
SEM Copper Bearing Steel

Areas Of Attack - Spotty Etch

Copper Bearing Steel (11 Mo. Exposure)

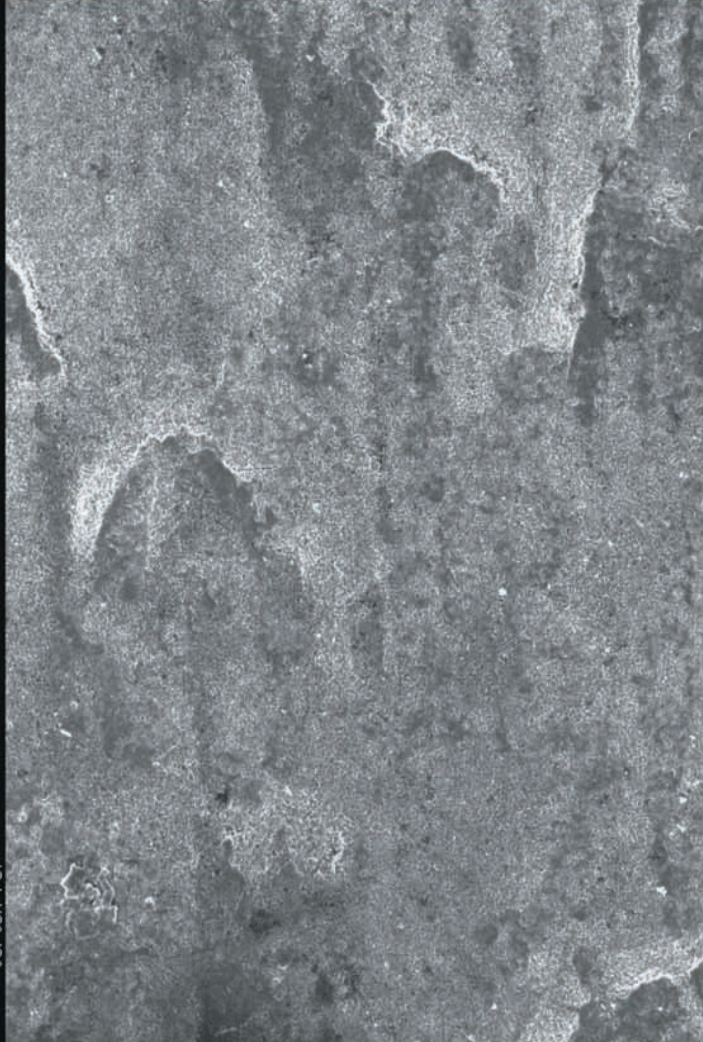
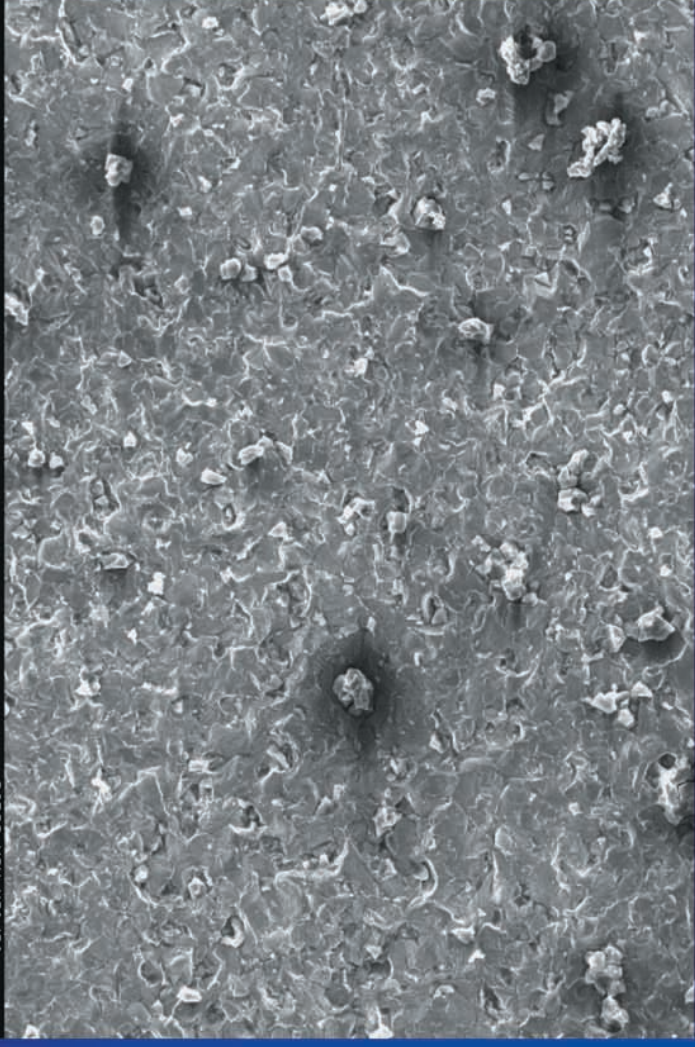
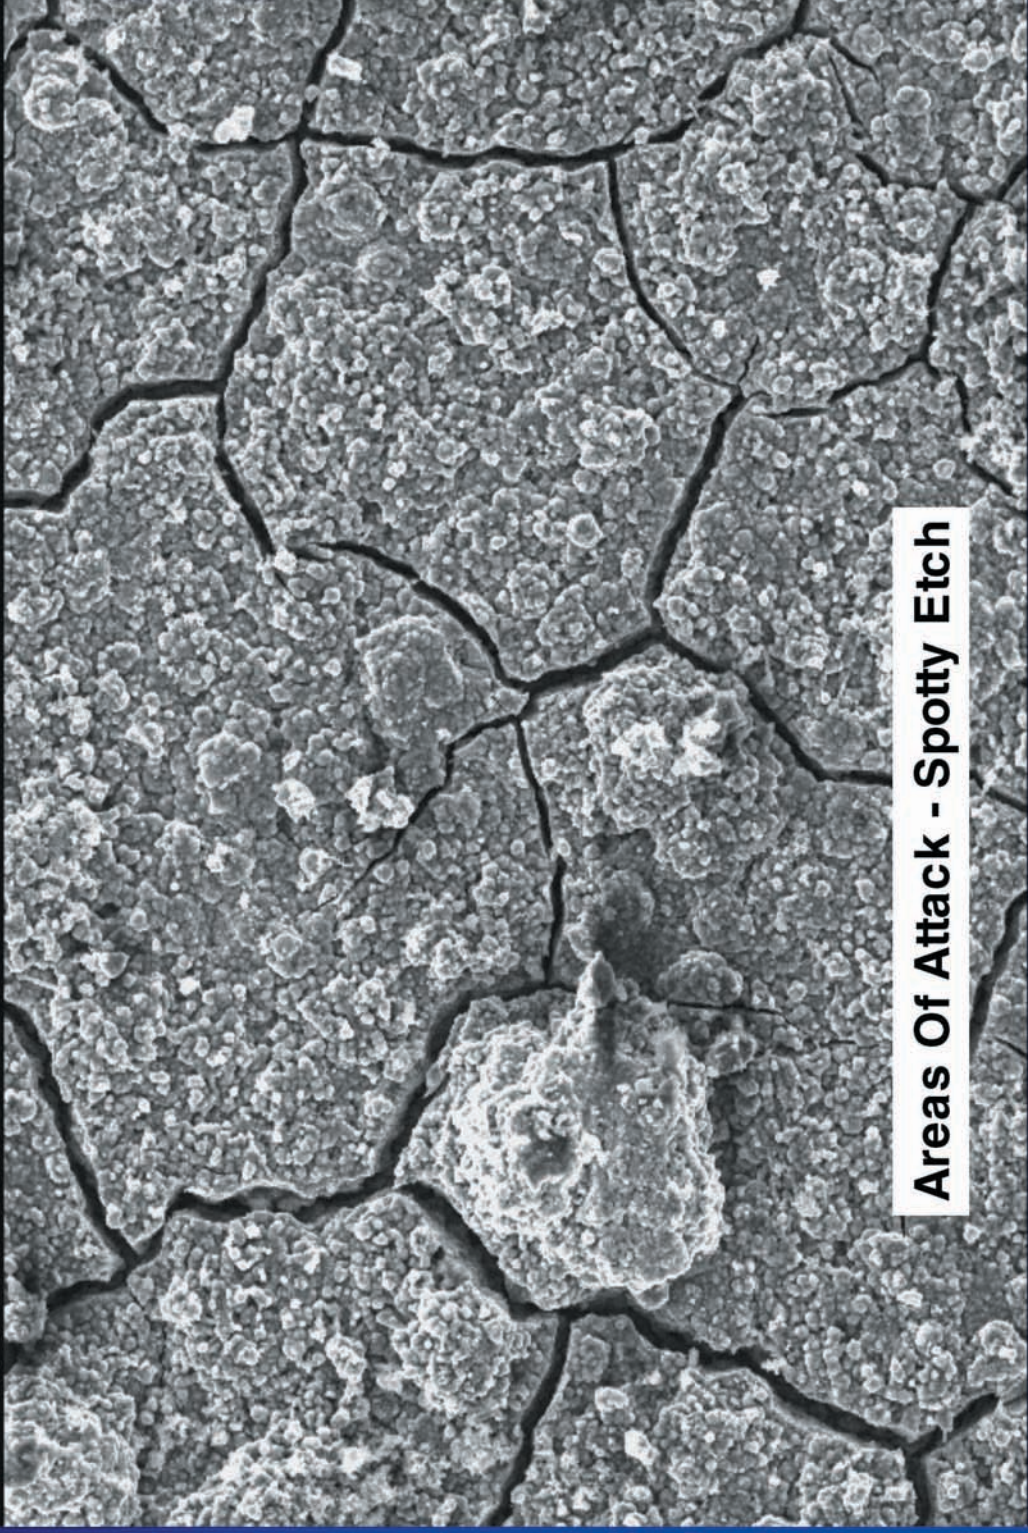
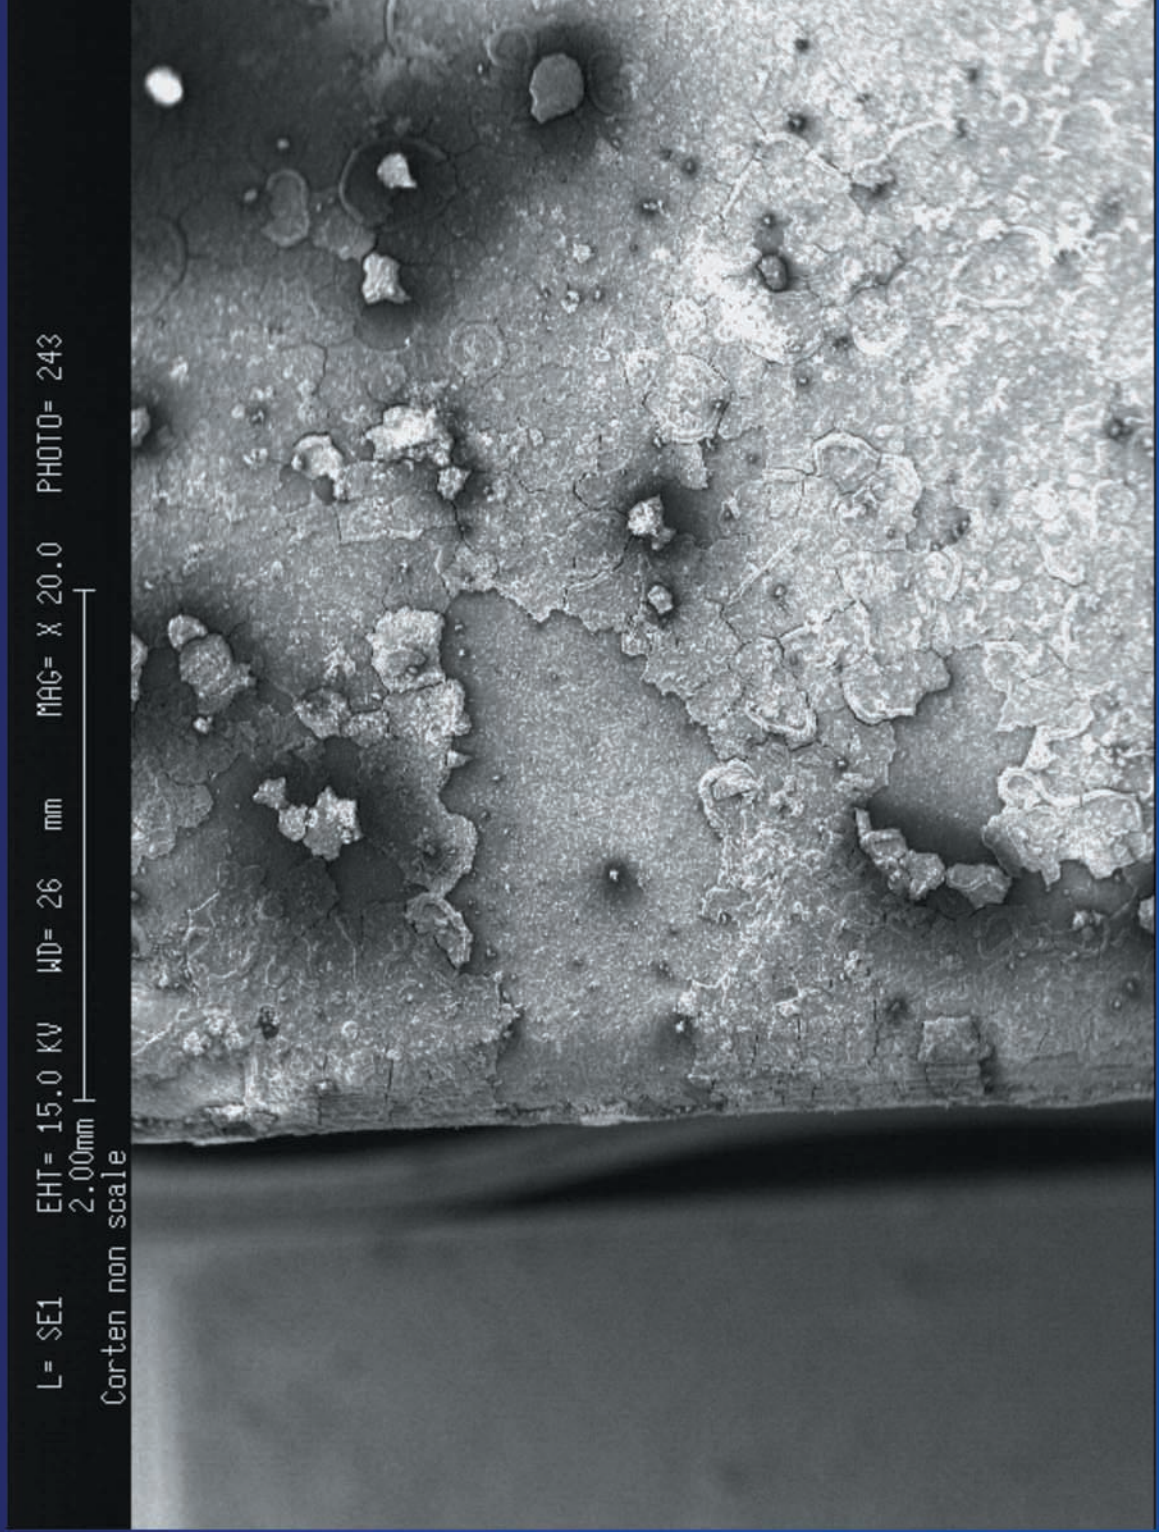
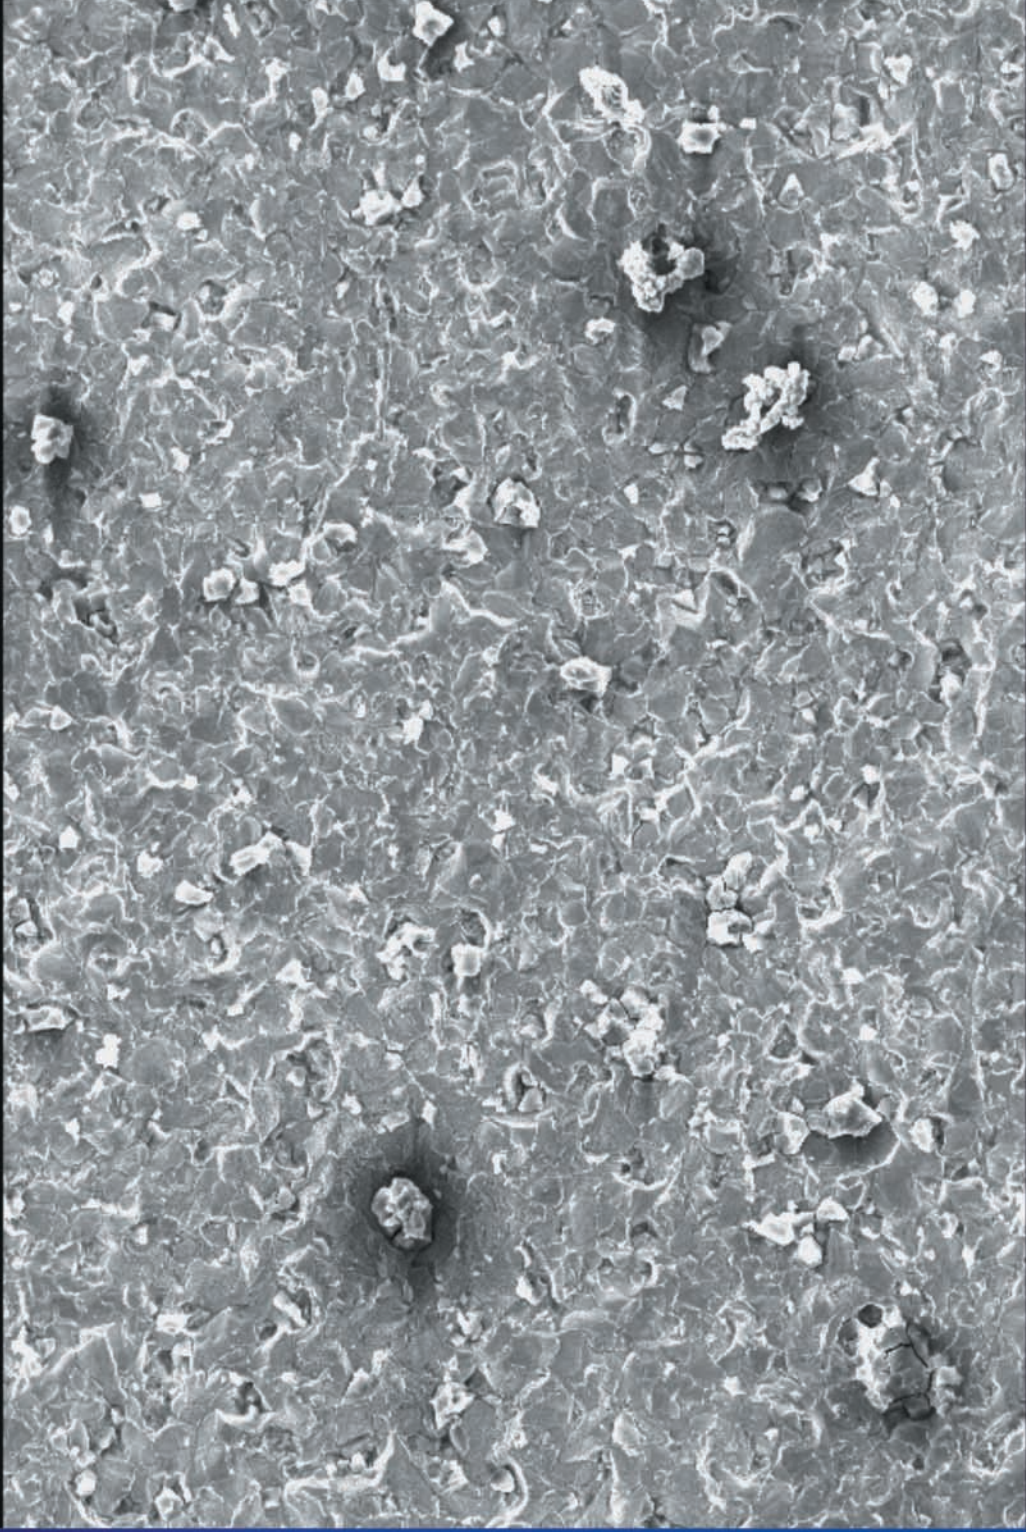
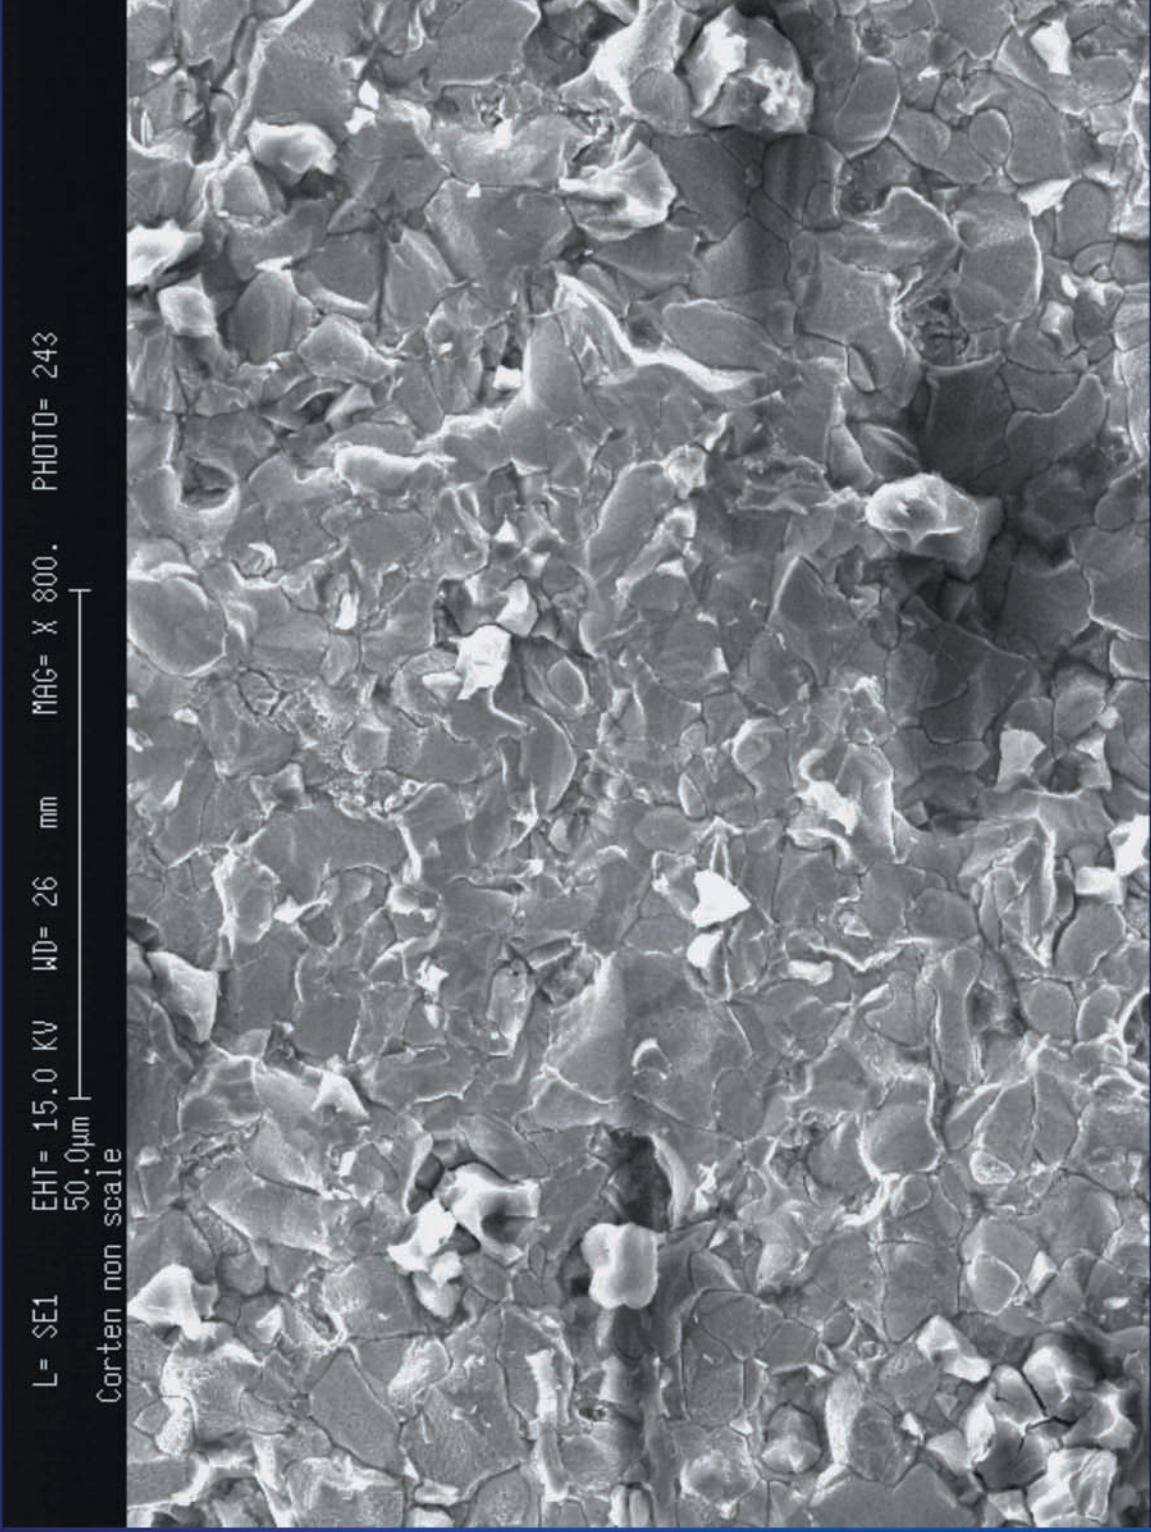
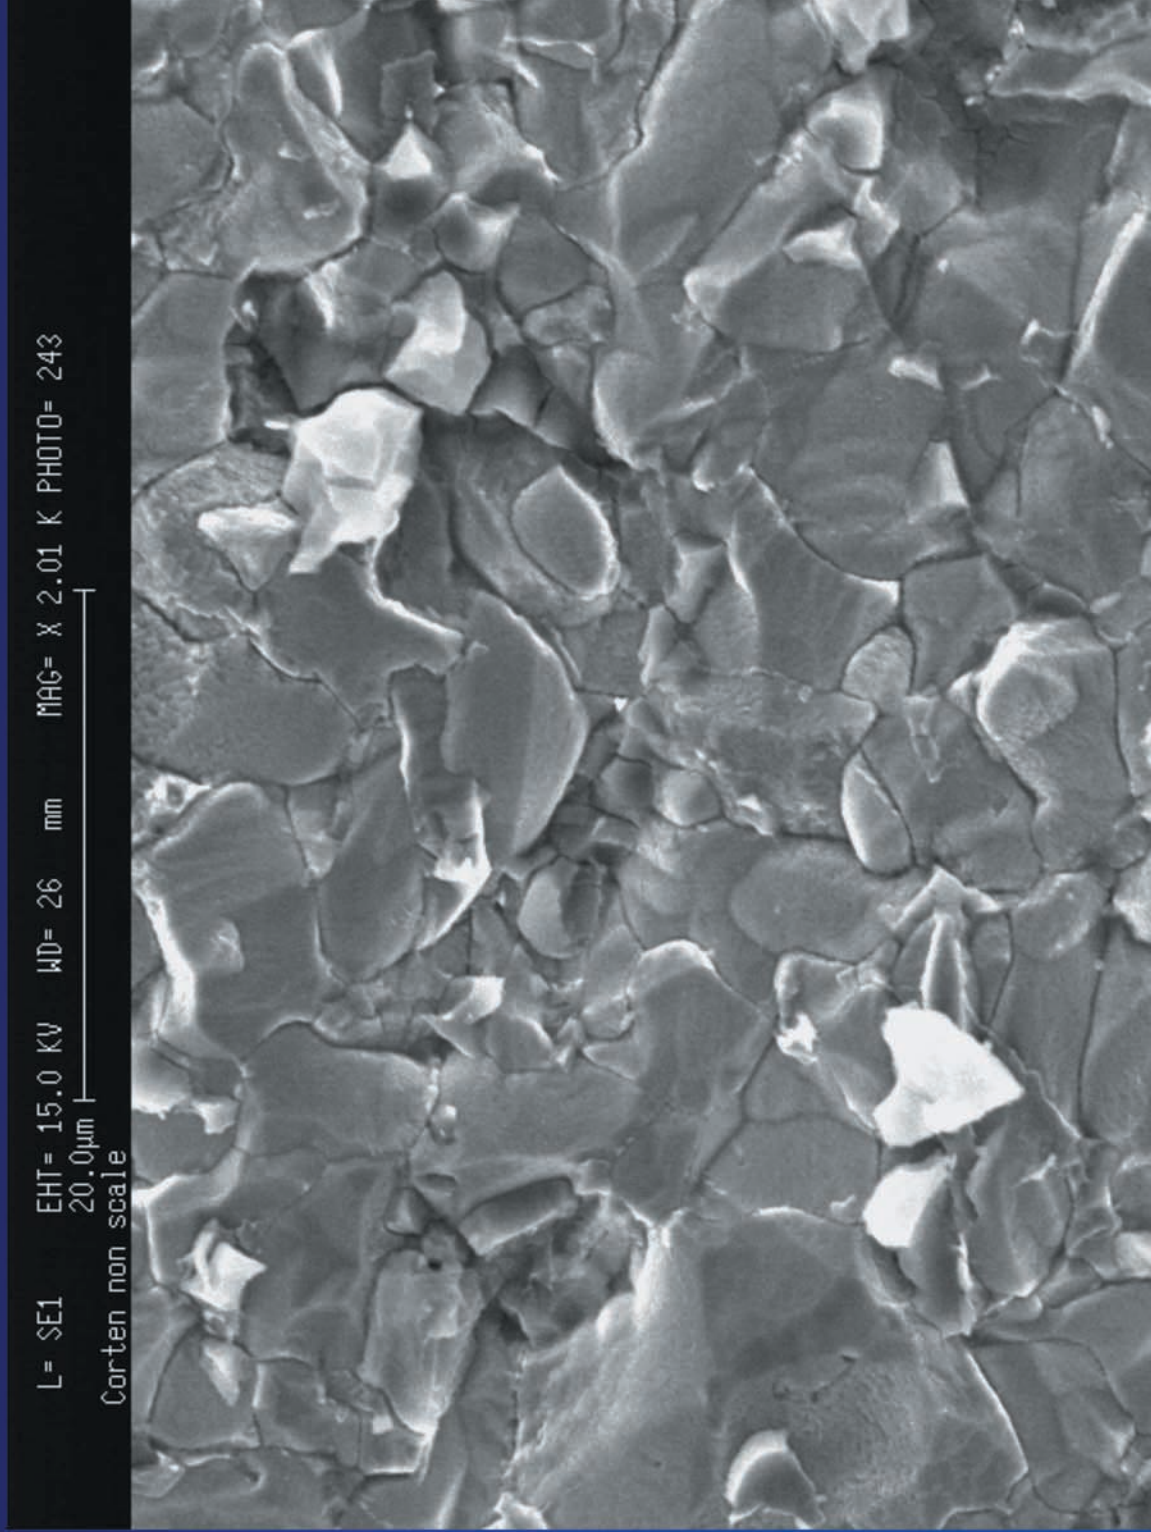
The Copper Bearing and Corten coupons suffered spotty etch and areas of attack. SEM photographs reveal the grain boundaries of the Corten to be more disfigured after eleven months than grain boundaries in the stainless steel coupons (see Appendix B). Light microscope photographs showing the Copper Bearing and Corten steel coupons after eleven months of submergence (before cleaning) can be found in Figure 5.

SEM Corten Steel

Areas Of Attack - Spotty Etch

Scale Area

Note
Grain
Boundaries
