CORROSION FIELD TEST OF STEELS COMMONLY USED IN WELL CASING AND SCREEN

City of Fountain Valley

July 29, 1999

WELL NO. 7

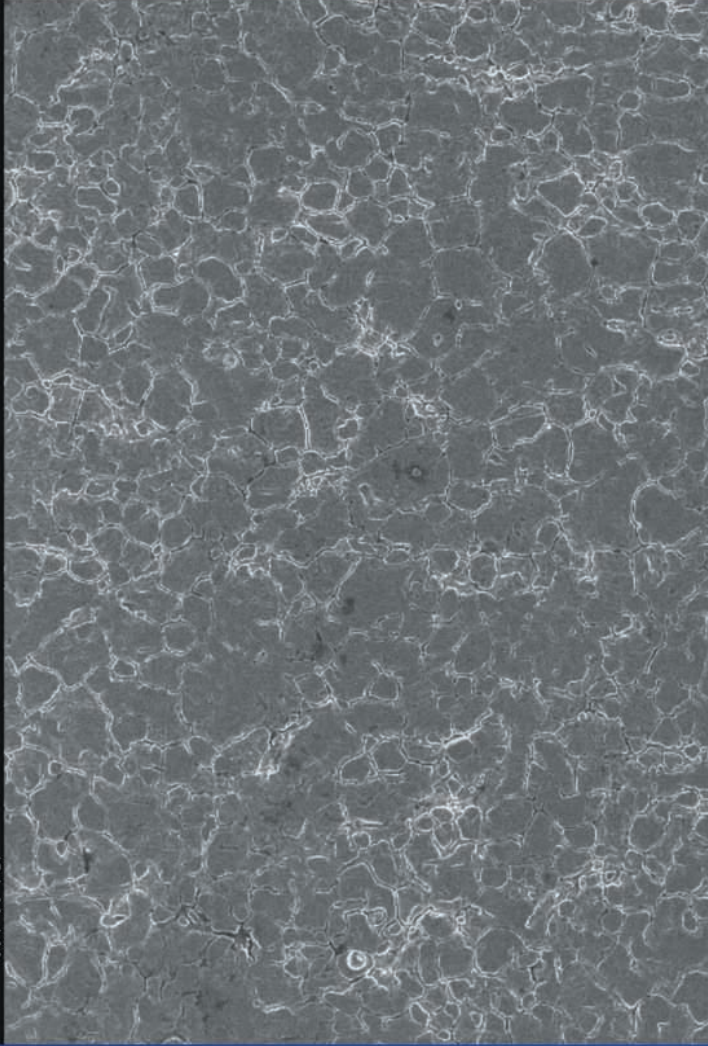
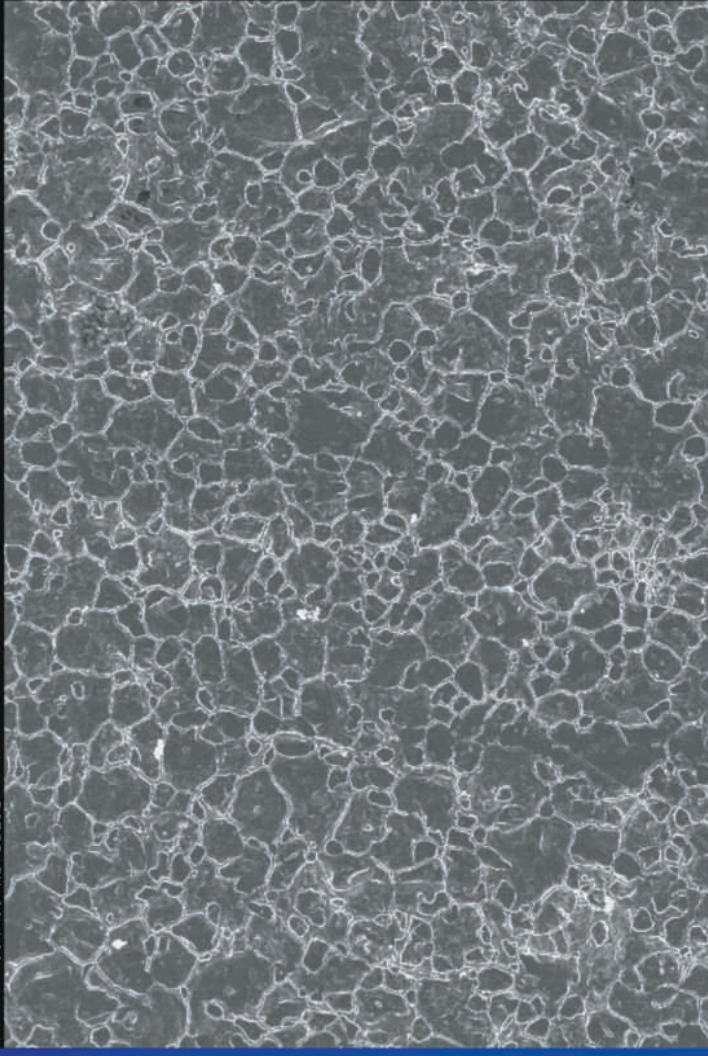
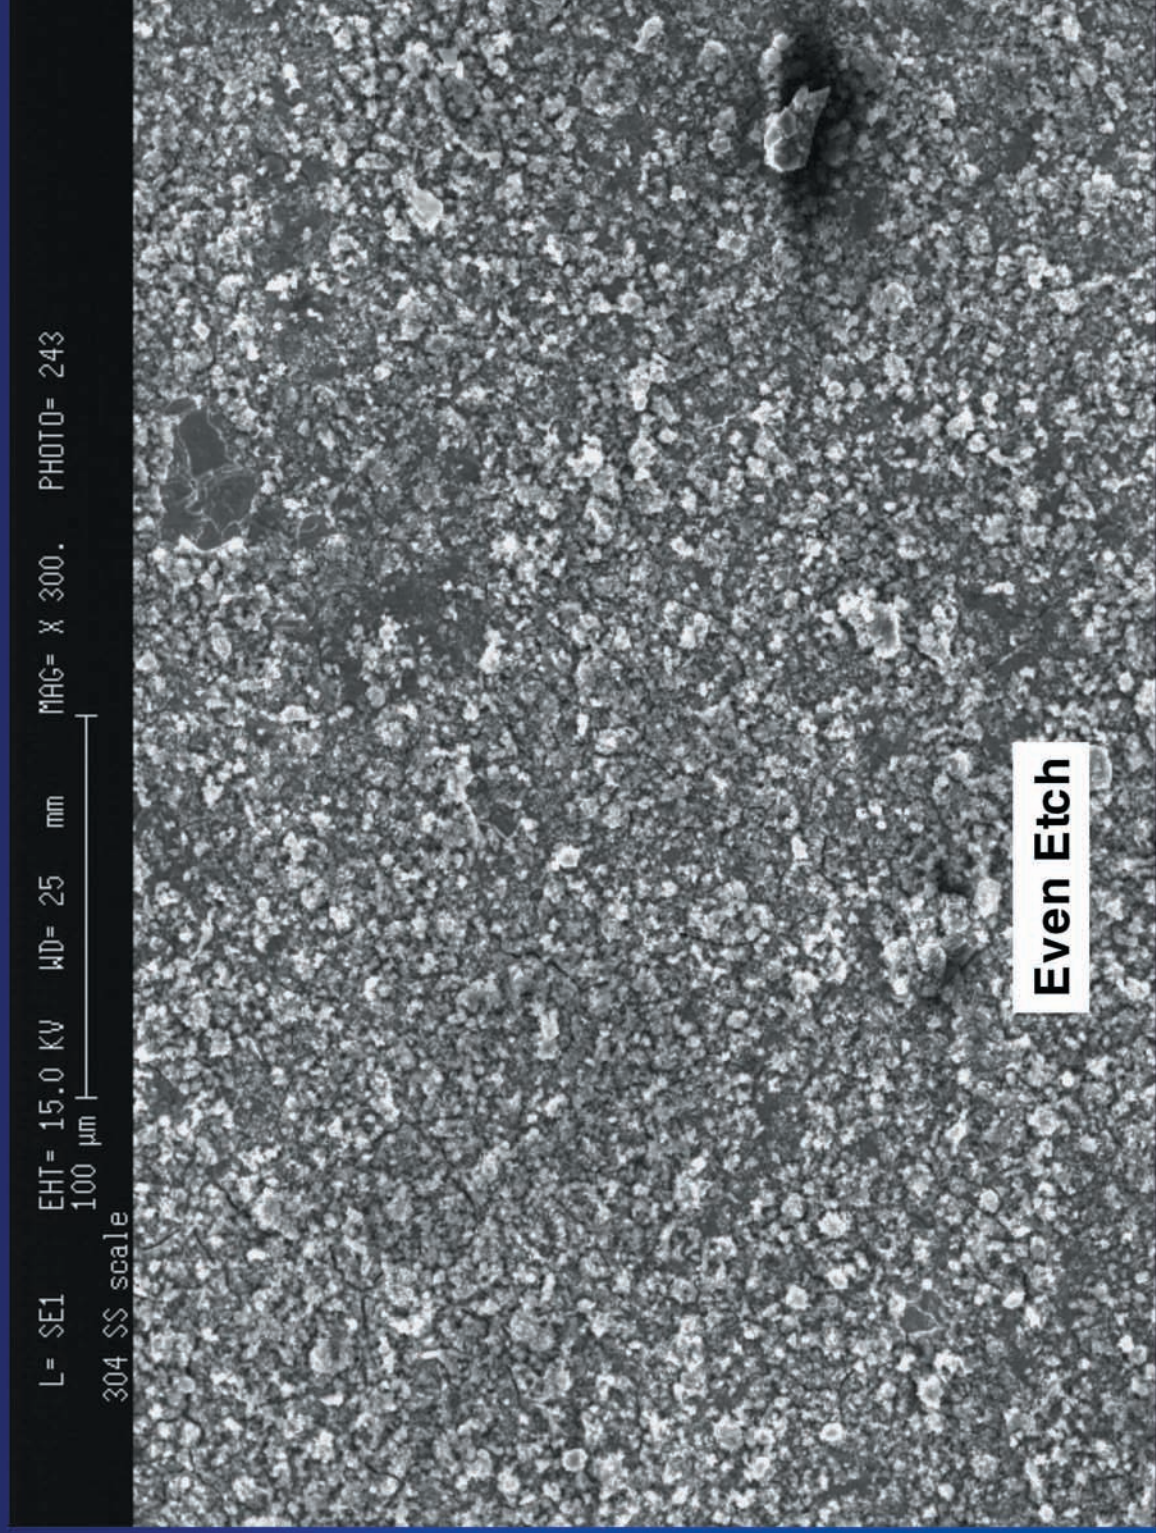
SEM Stainless Steel 304

Note
Grain Boundaries

Even Etch

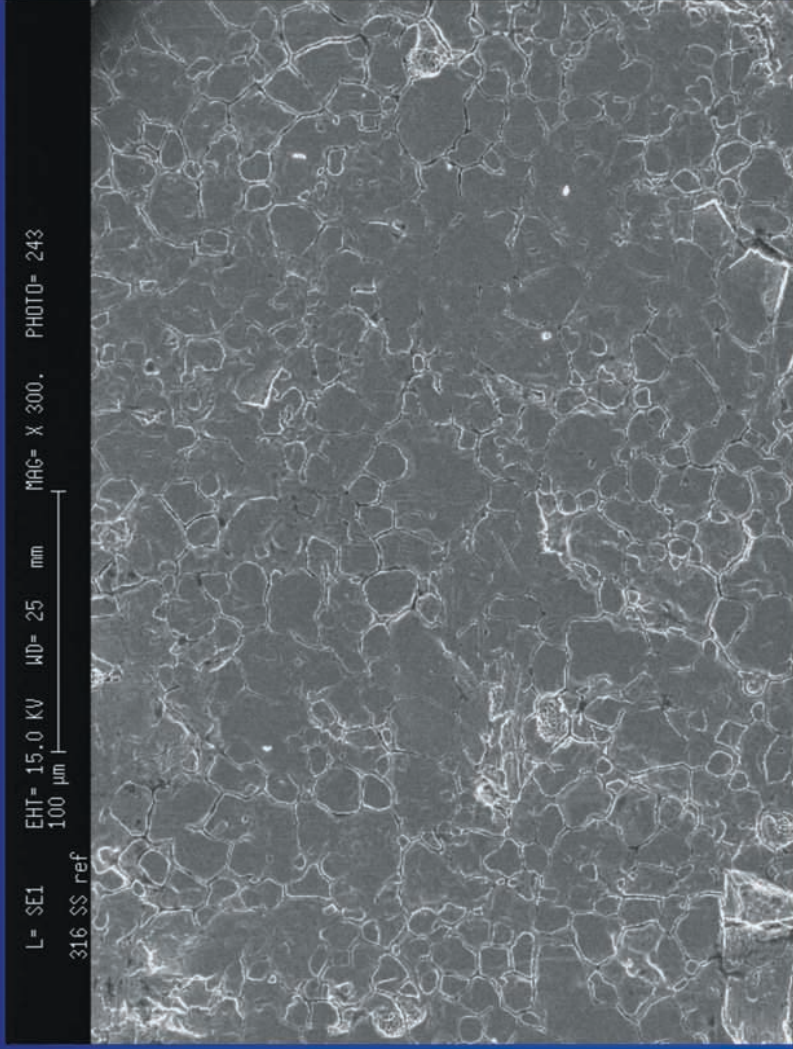
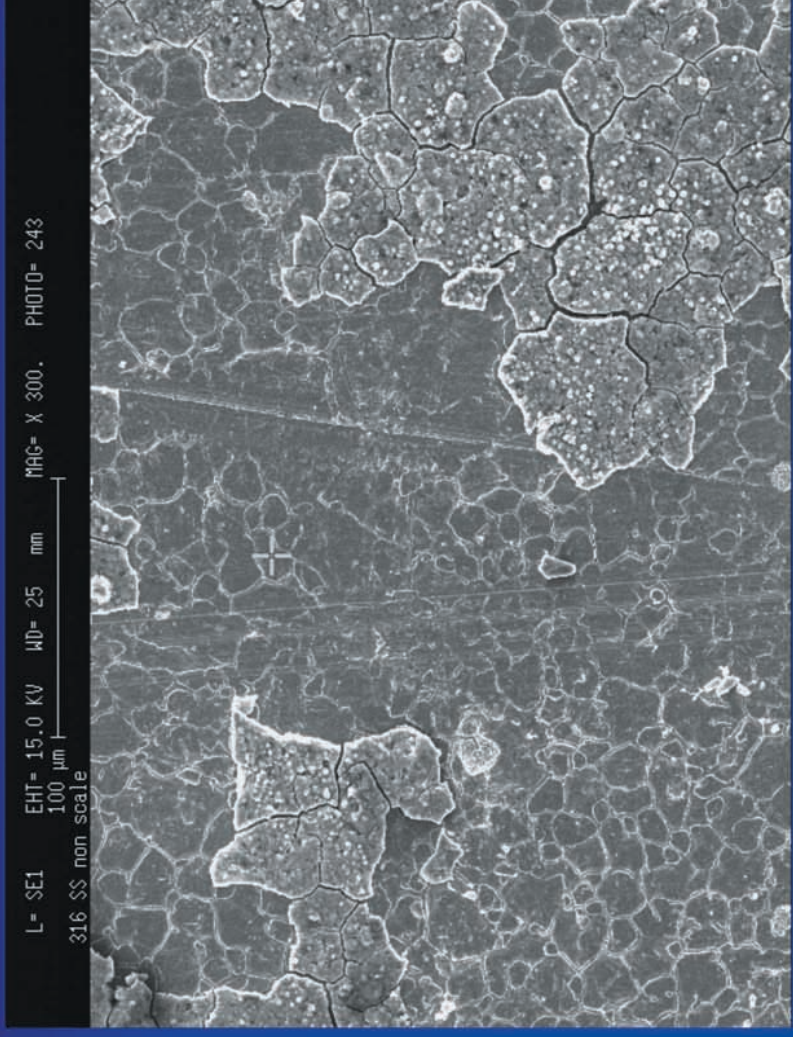
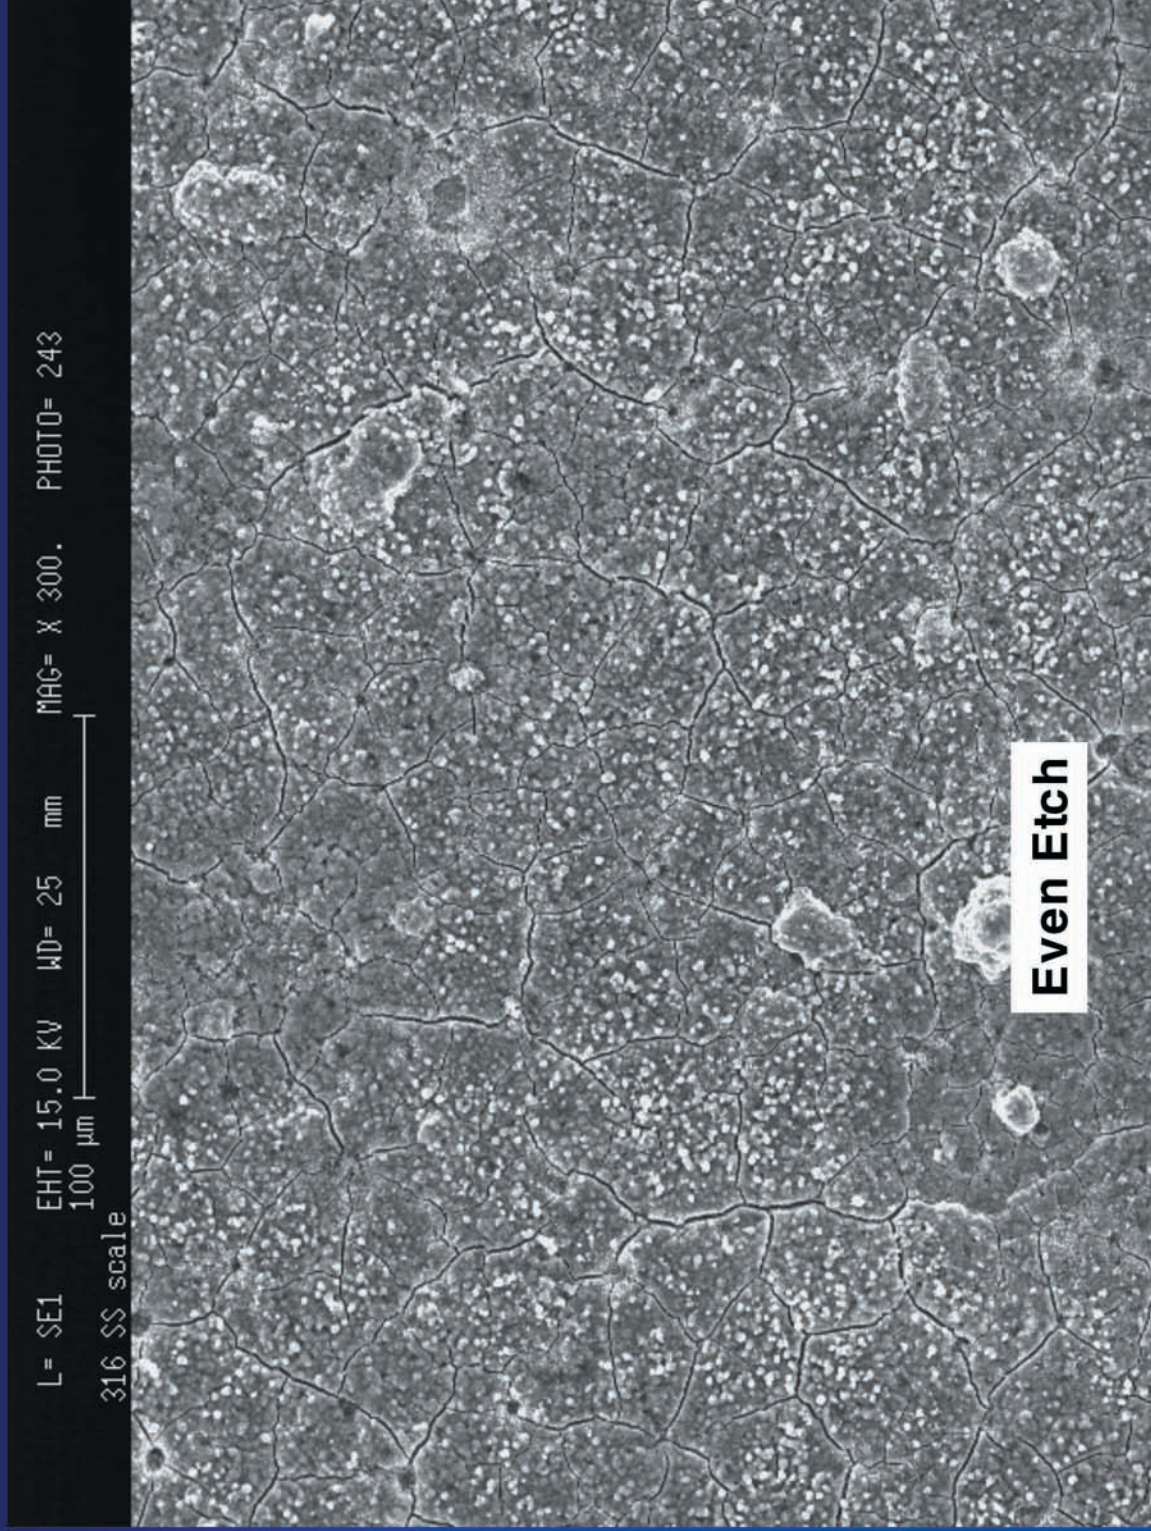
The stainless steel coupons suffered the least corrosion, classified as even etch. The scale area on the stainless steel 316L coupon is characterized by elevated oxygen, sulfur, silicon, and calcium levels compared to the reference coupon. Non-scale areas nearly perfectly retain the same chemical signature as the reference coupon as determined by EDS (see Appendix C). Light microscope photographs showing the stainless steel coupons after eleven months of submergence (before cleaning) can be found in Figures 6 and 6a.

Stainless Steel 316L - Reference Coupon

Note
Grain Boundaries

Even Etch
